PRIVATE & CONFIDENTIAL REF: 0493/19

BUILDING SURVEY ON \*\*\*\*\*

Date of Survey: Two separate visits – \*\*\*\*\* and \*\*\*\*\*

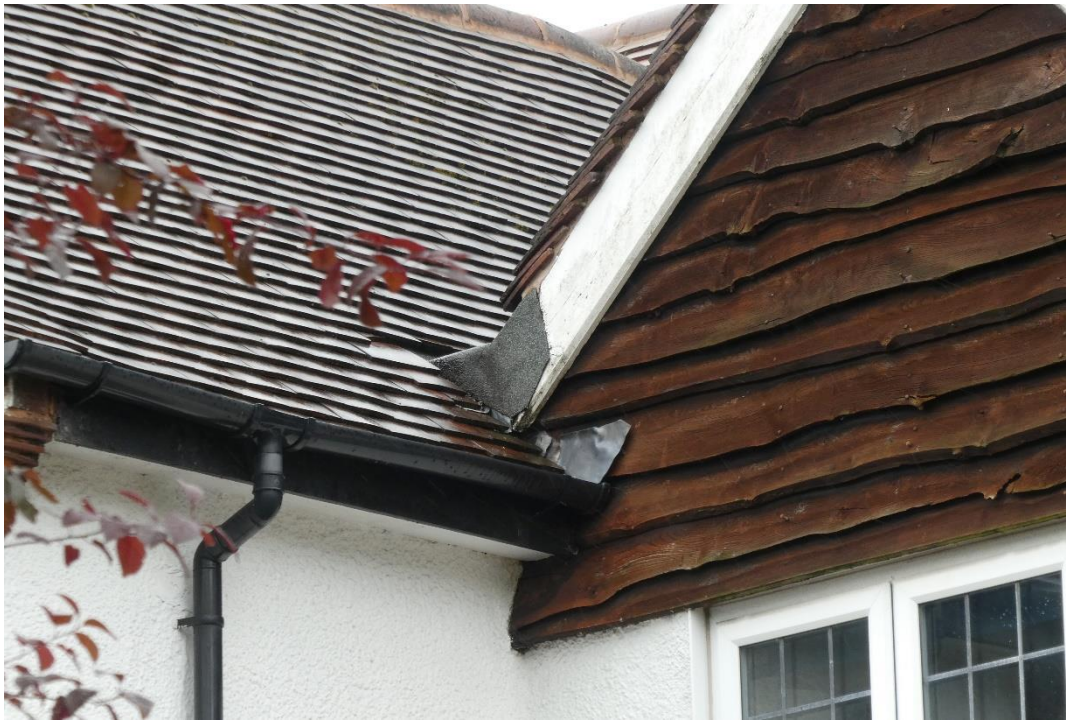
7. The valley above bedroom one and bedroom four has been replaced due to extensive leakage. It has been replaced in felt and not lead or single ply membrane (EPDM). Although this appears to have addressed the leakage, we would have preferred to see the valley lined with lead or EPDM as the felt will only give you ten to twelve years (from new) of waterproofness. Your solicitor should obtain the guarantee.

REPAIR TO VALLEY HAS BEEN CARRIED OUT IN BITUMEN FELT.

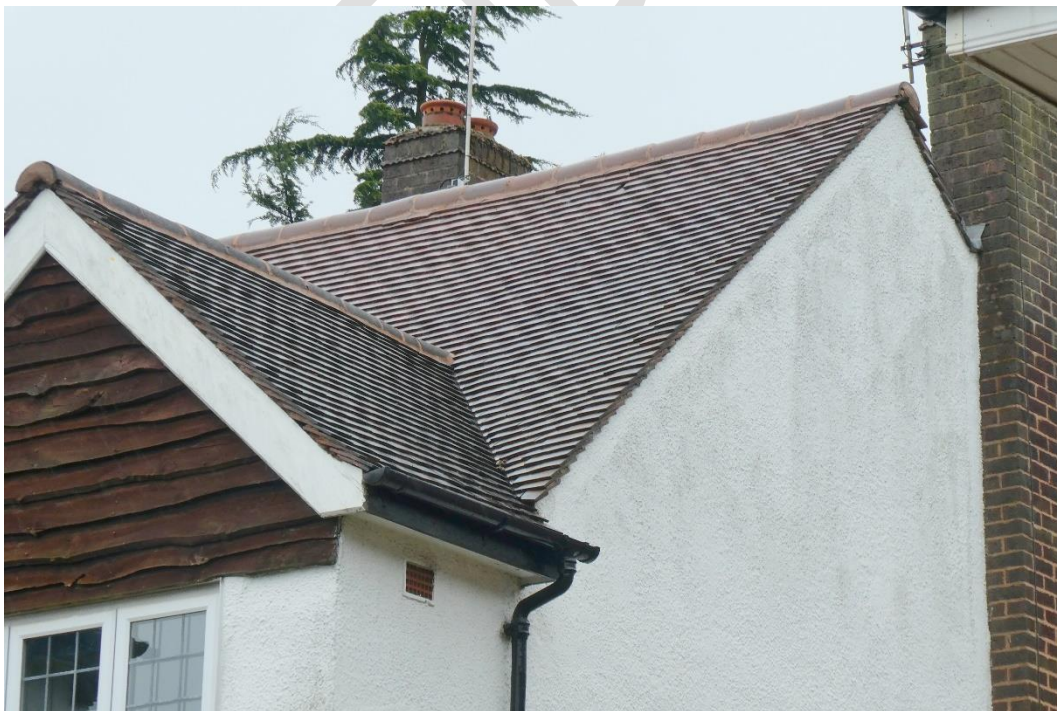
TILES TO FRONT ELEVATION ARE IN GOOD CONDITION. THIS IS THE AREA WHERE THE DEFLECTED PURLIN CAN BE SEEN IN THE ROOF-LINE (NOT OBVIOUS ON PHOTOGRAPH).

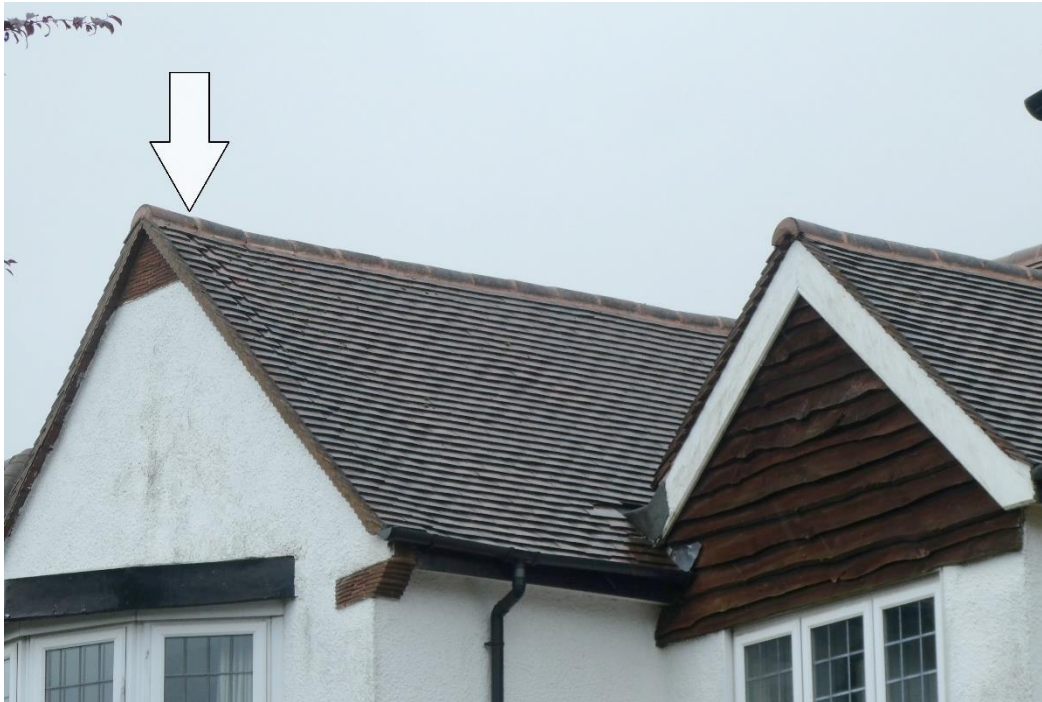
NOTE GAP TO TILES ABOVE FRONT GABLE.

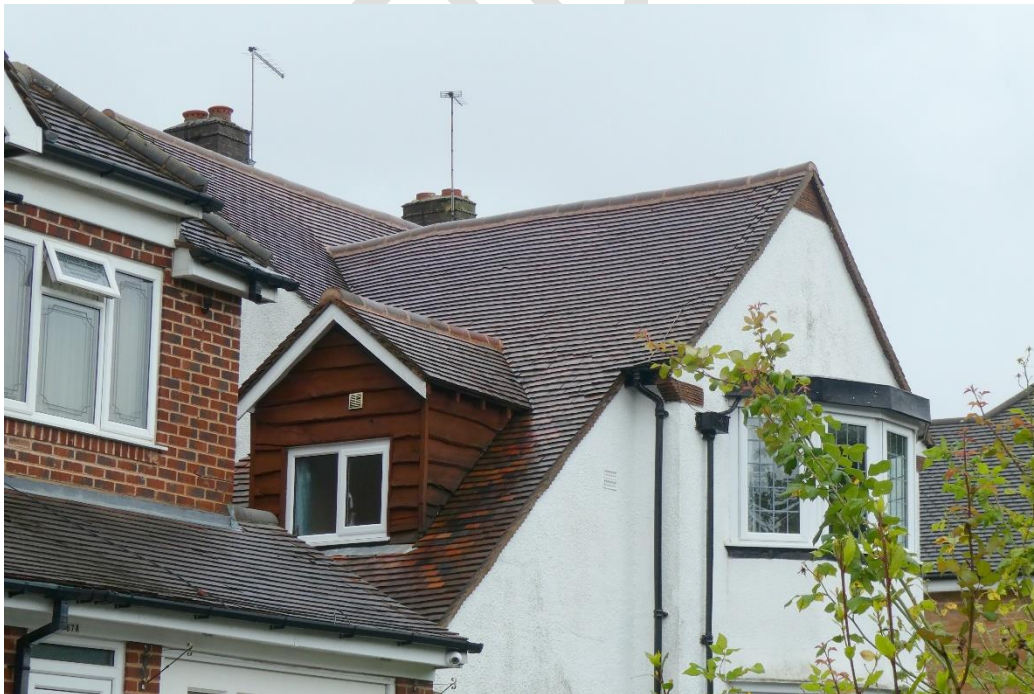
AGAIN, ROOF TILES IN GOOD CONDITION. NOTE WANEY EDGE BOARDS TO THE ENSUITE WALLS.

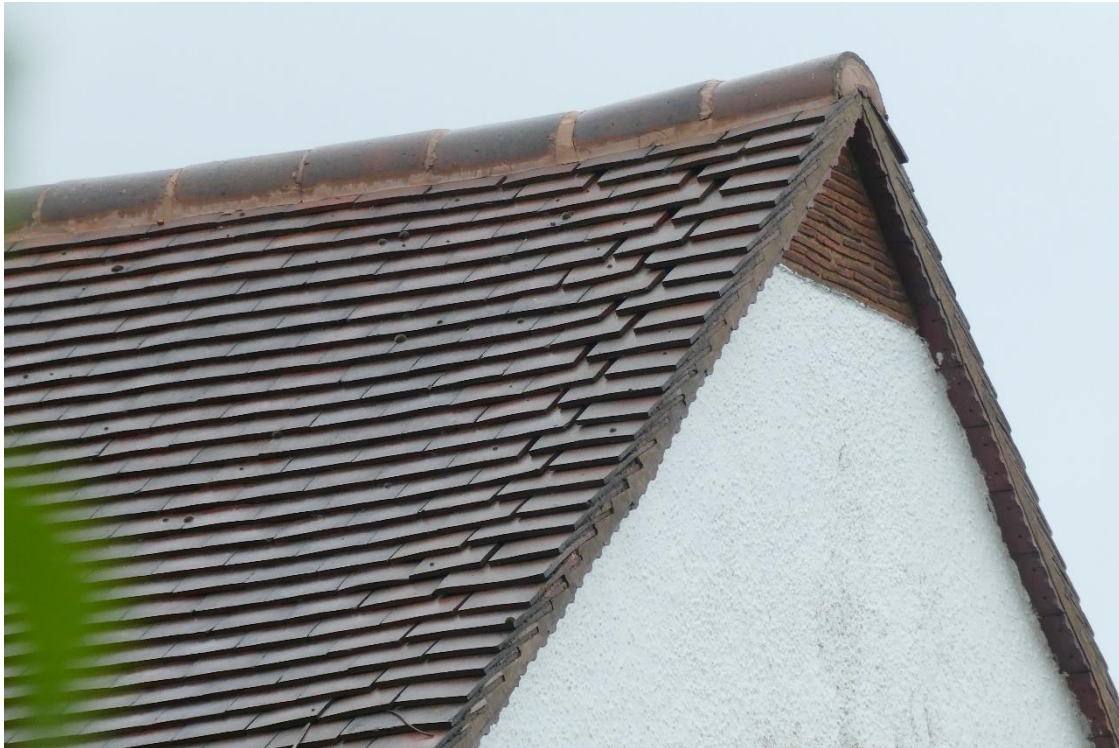
GAP TO THE TILES TO THE OTHER SIDE OF FRONT GABLE.

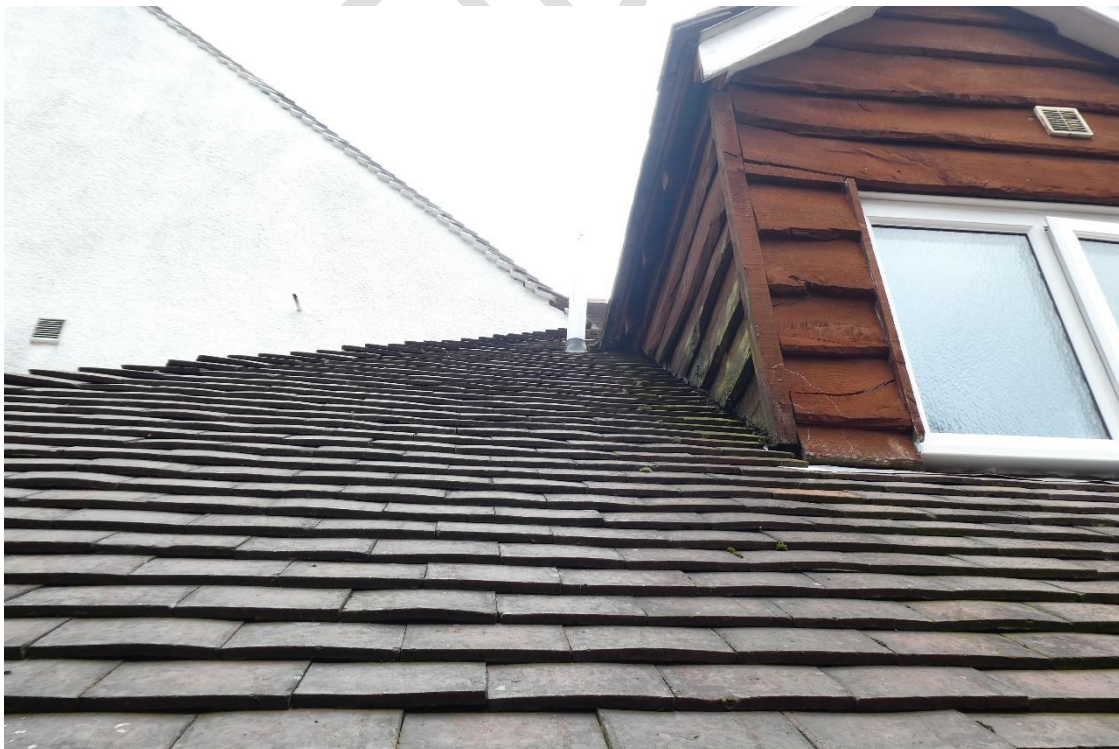
WANEY EDGE BOARDS. THE DAMP INTERNAL CUPBOARD IS INSIDE THIS AREA.

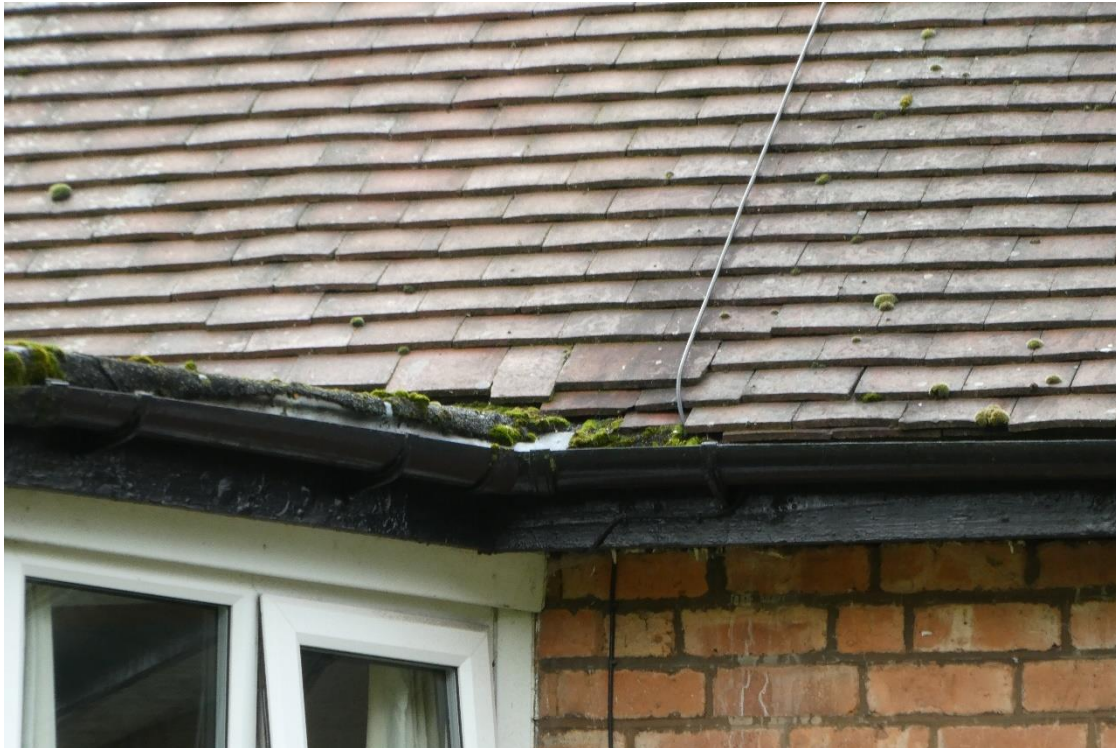
TILES ABOVE THE FLAT ROOF ARE BEING AFFECTED BY DAMPNESS.

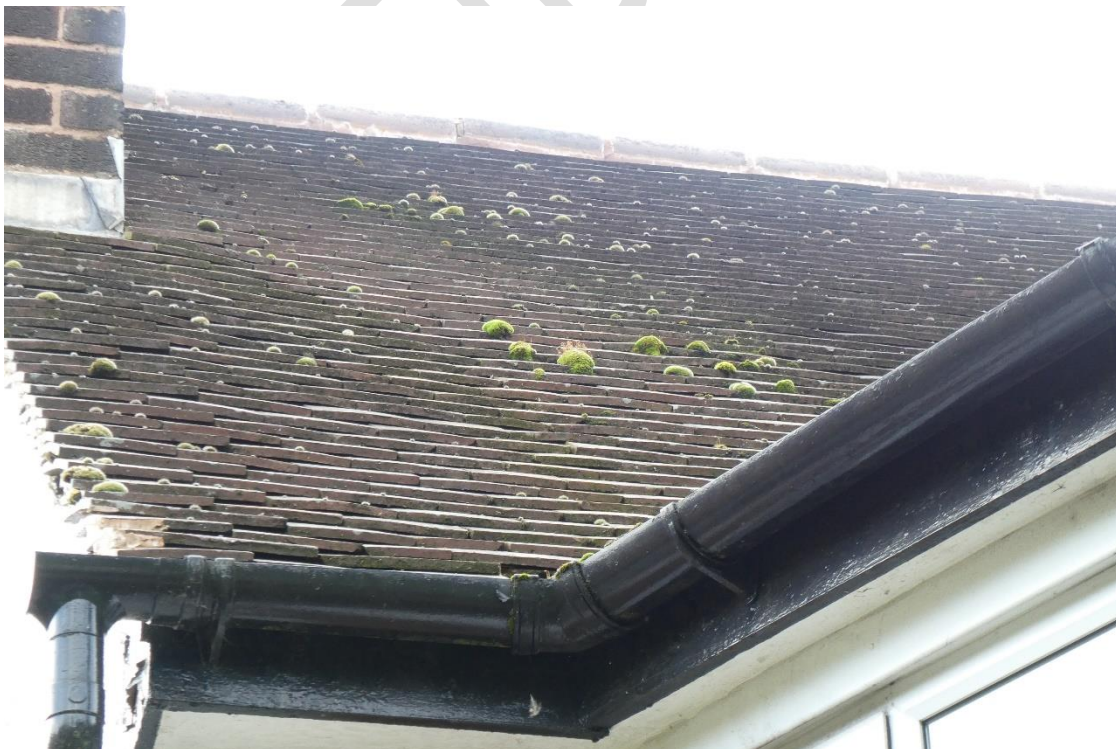
MOSS TO REAR ELEVATION.

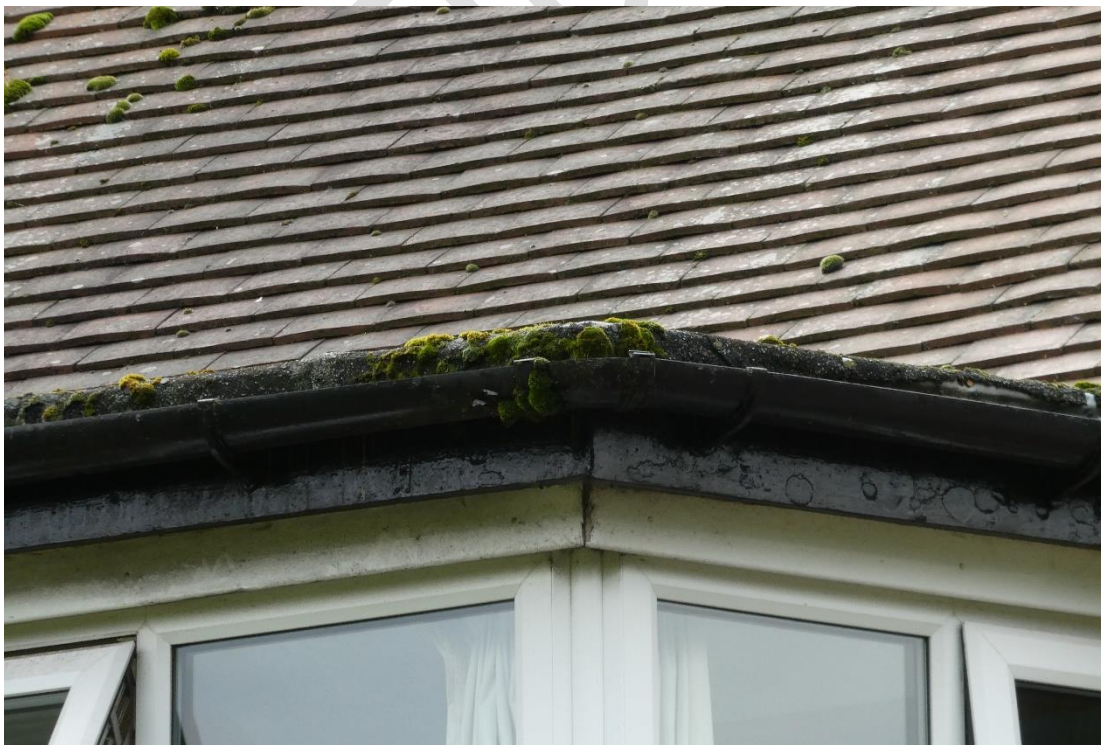
OLD FELT COVERED IN MOSS TO REAR BAY.

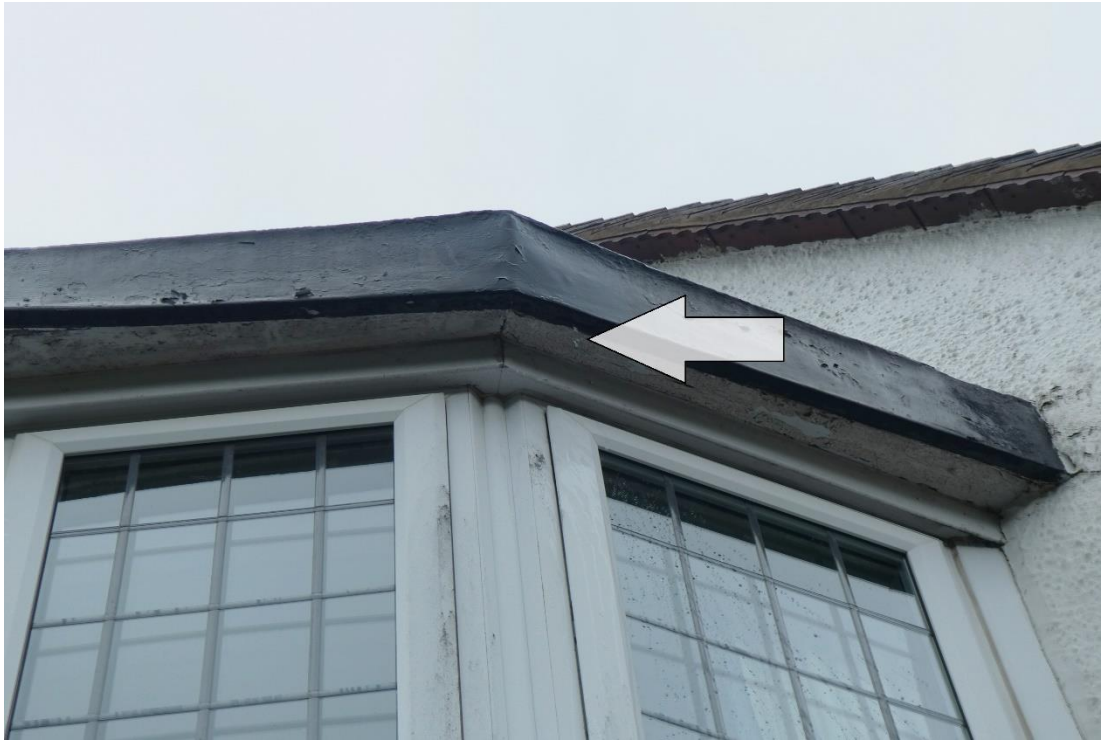
3.11 There were no obvious signs of leakage beneath this roof, but the integral gutter is leaking behind the apron (see section 8.00).

LEAD/ZINC APRON TO FRONT BAY. RAINWATER IS DRIPPING FROM BEHIND IT (SEE SECTION 8.00).

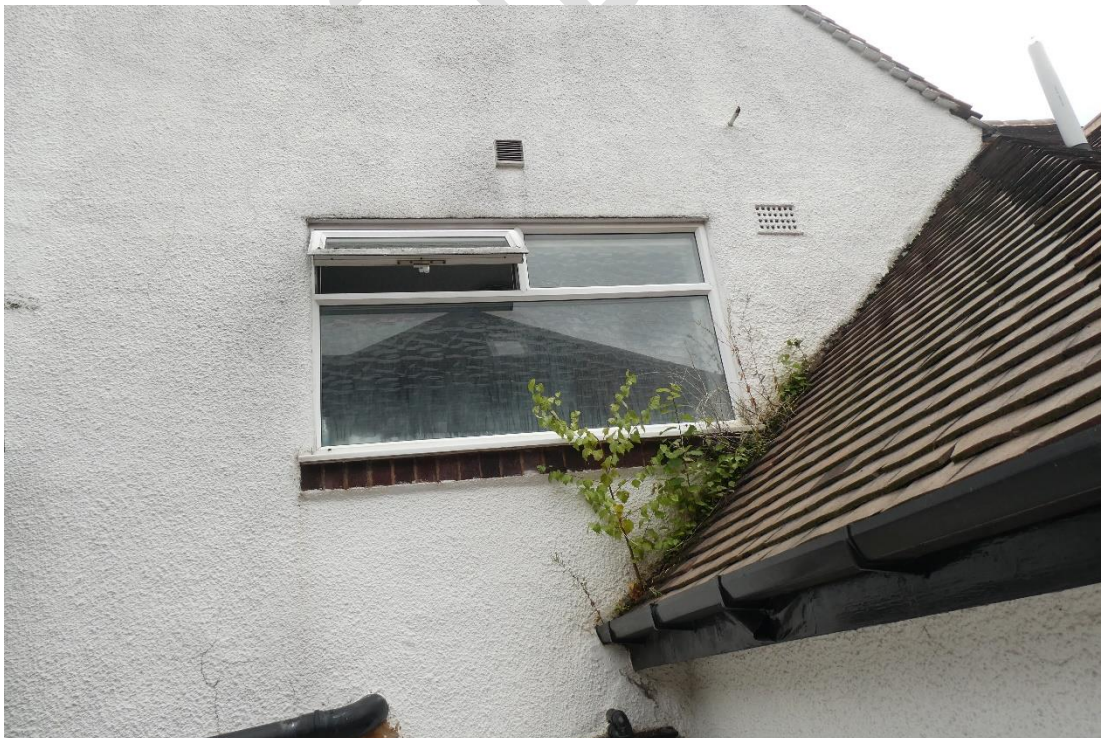
8. To the abutment of the garage roof and main house wall, there are saplings growing in the flashing. These should be removed.
9. Further up this abutment, is the area above the cupboard within the ensuite entrance. Within this cupboard, there is extensive leakage. We notified the vendor and following our inspection, the vendor has contacted us and confirmed that there was an internal plumbing leak and possibly a roof leak which is being investigated. We do not know whether these leaks have been repaired. You should discuss this with the vendors and ensure that guarantees are passed to you in your name.

REMOVE SAPPLINGS.

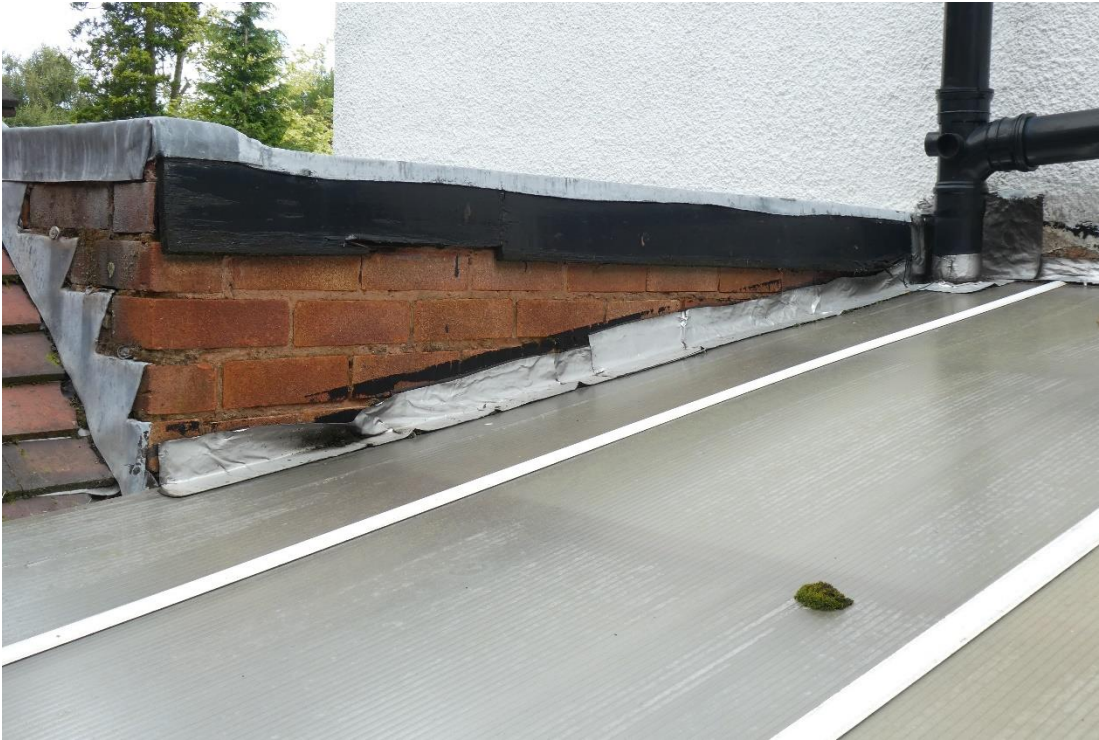
3.17 The roof sheets are flashed with aged bitumen tape against the single skin utility parapet wall. This has de-bonded and is contributing to the leakage within the covered area and may also be the source of damp readings to the parapet within the utility. Although this is an open plant growing area, the leakage is concentrated around the edge of the roof sheets which is dampening the walls, so we recommend that the flashings are renewed.

OLD BITUMEN TAPE ABOVE COVERED AREA. THIS IS THE SINGLE SKIN PARAPET WALL TO THE UTILITY.

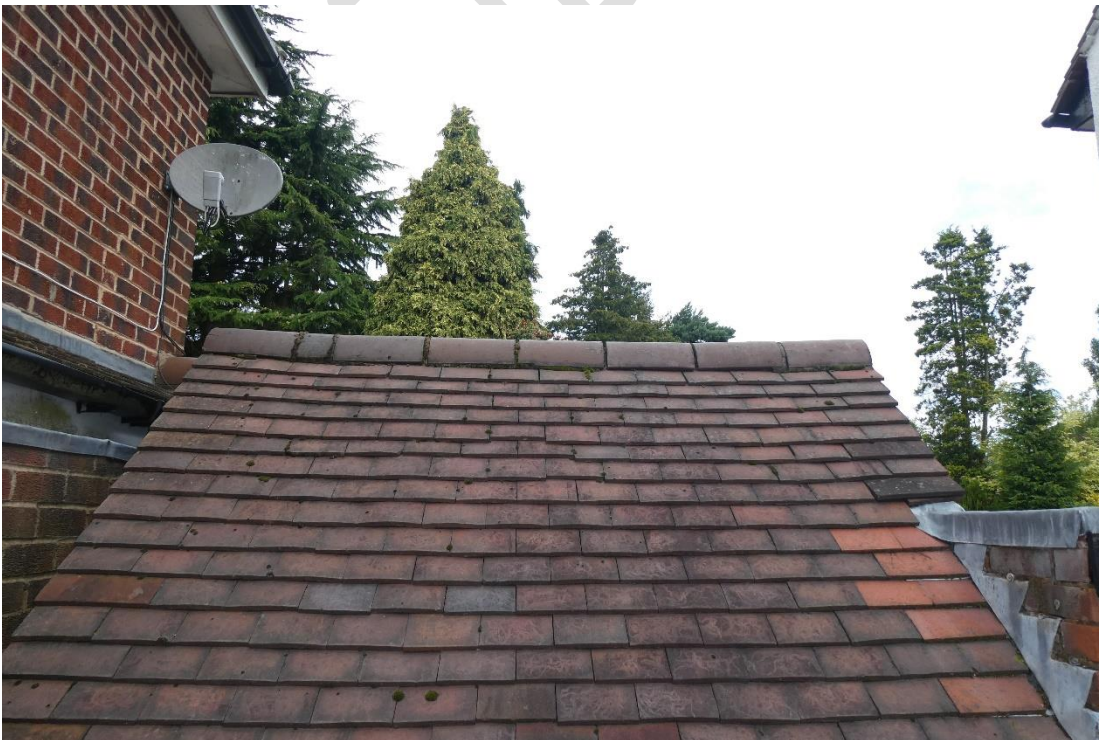
LOOKING AT THE FRONT ELEVATION OF THE UTILITY ROOF. RIDGE TILES NOT REPOINTED.

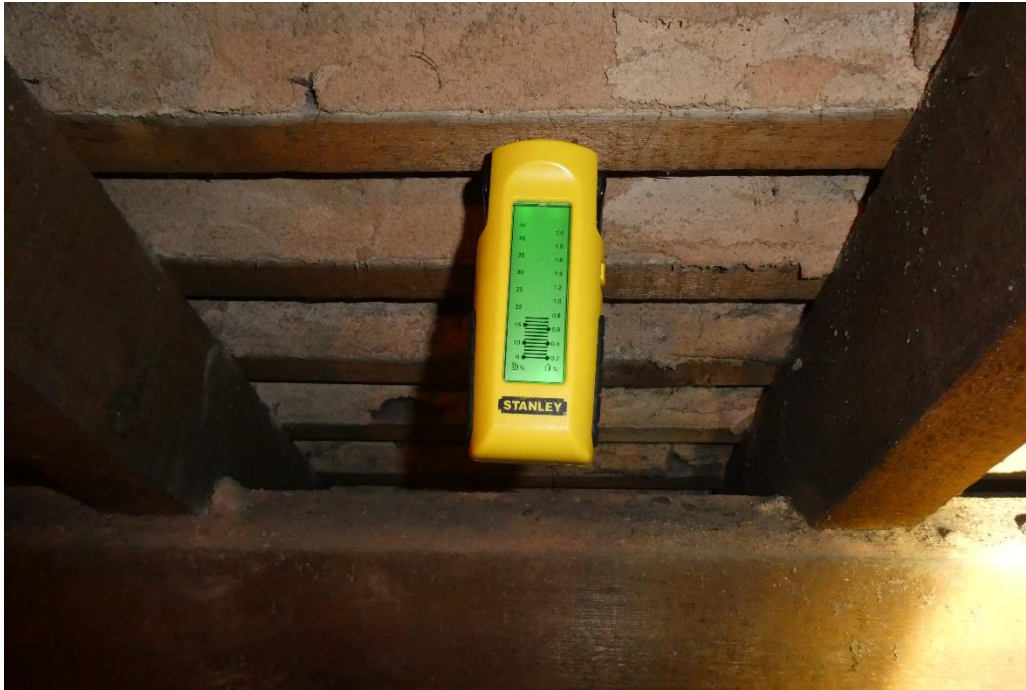
4.04 Surface moisture reading of battens indicated a reasonably low moisture content to battens. This indicates that the clay tiles are not leaching dampness through the battens.

SURFACE MOISTURE TO BATTEN.

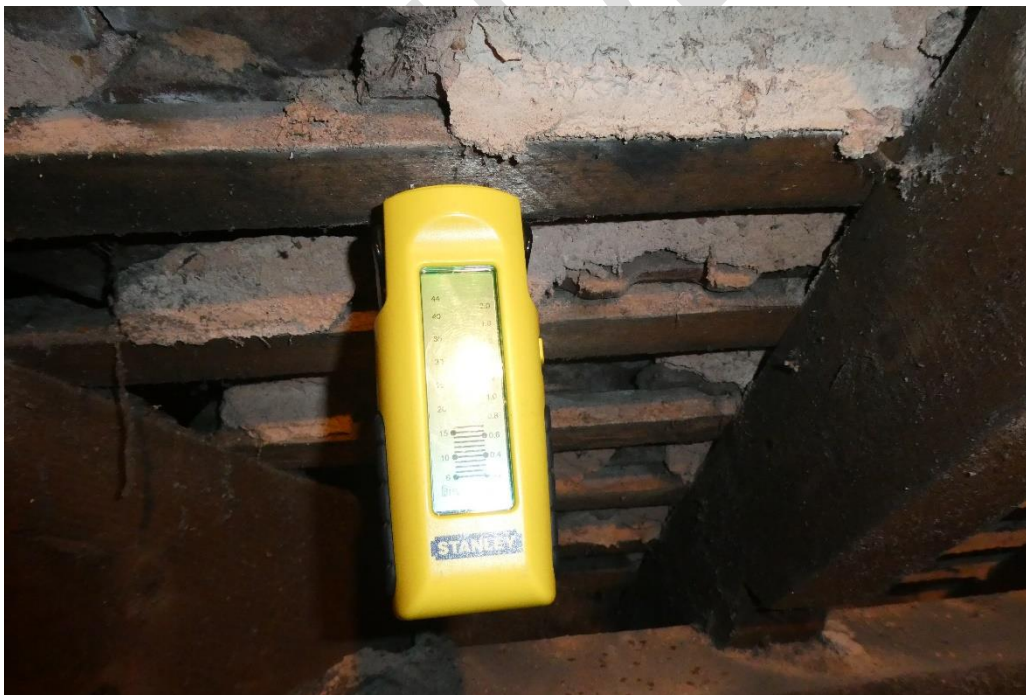
SURFACE MOISTURE TO BATTEN.

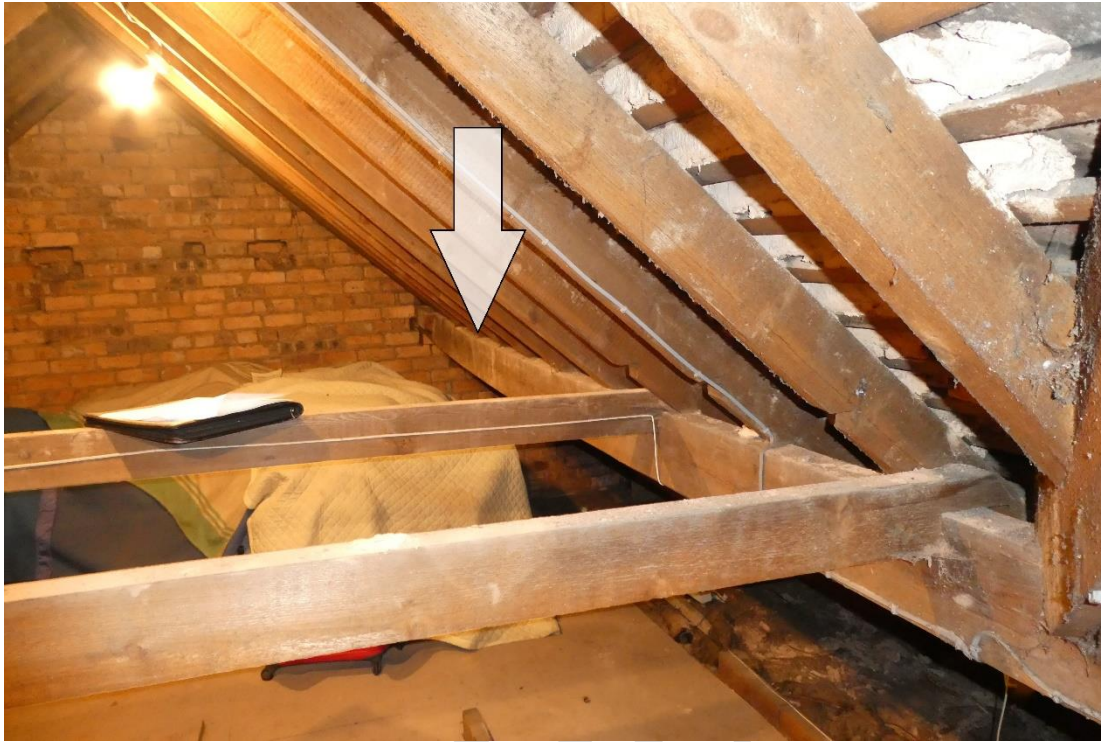
DEFLECTION CAN BE SEEN TO FRONT PURLIN.

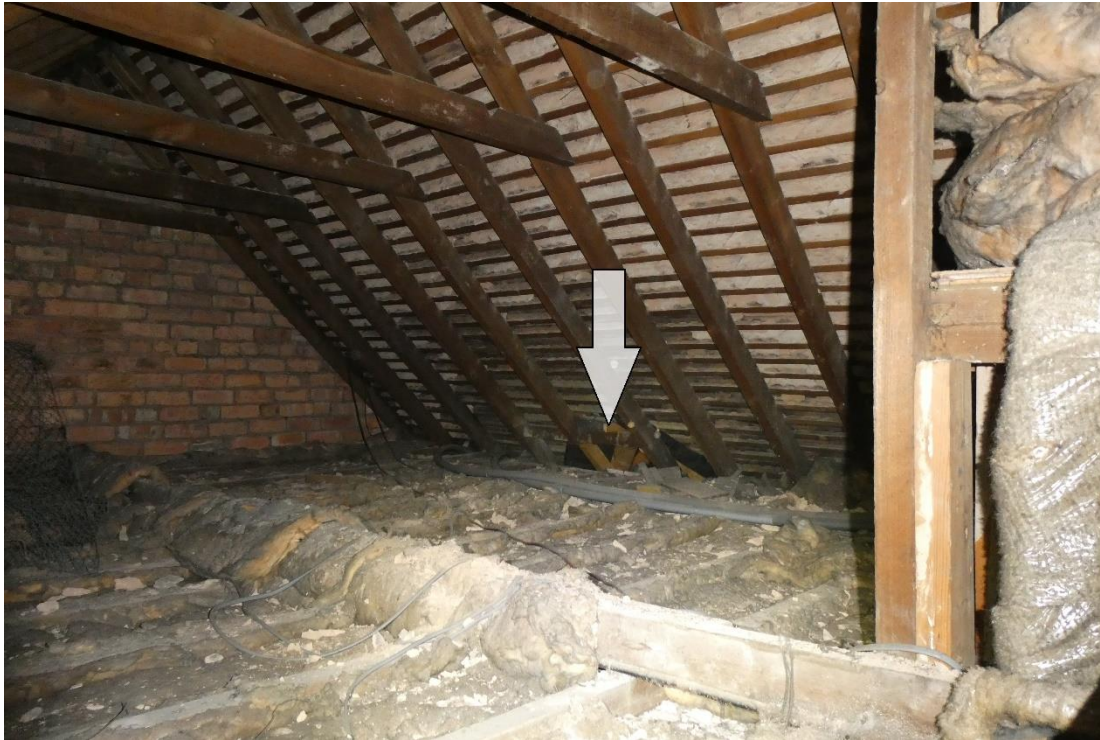
LOOKING INTO THE AREA ABOVE BEDROOM ONE. NOTE ENSUITE ROOF AT FLOOR LEVEL.

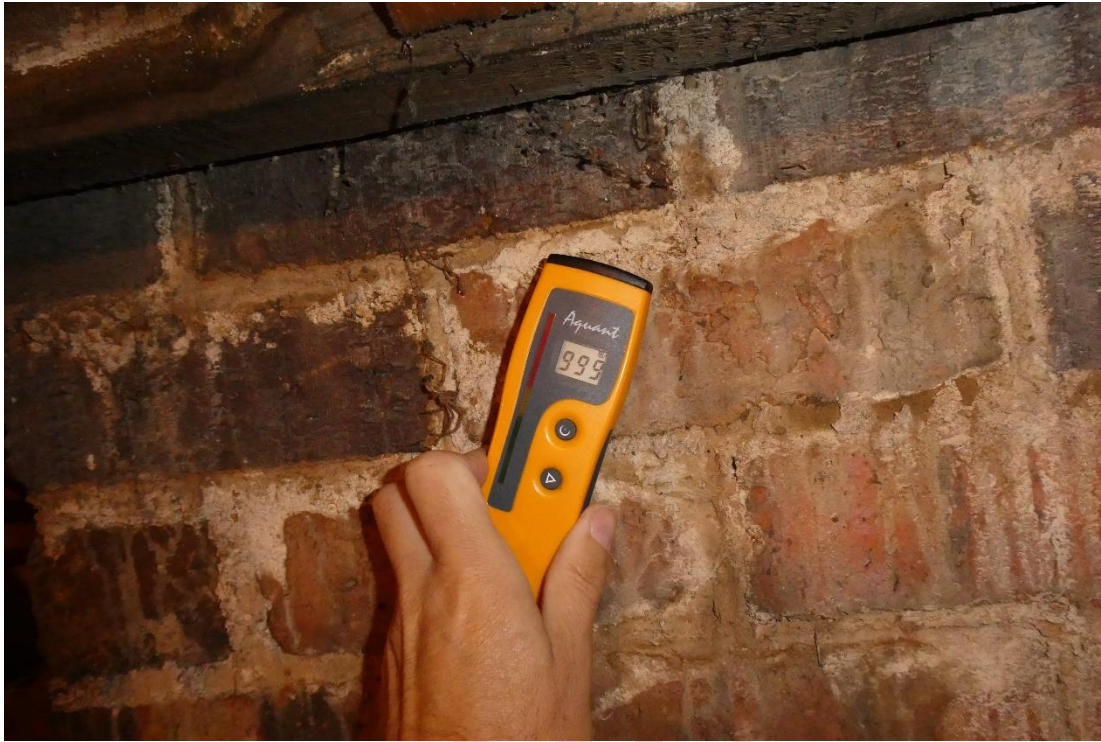
4.12 Chimney brickwork registered damp with a damp meter. Although this is normal, we noted loose flashings to the stack and have recommended works in section 5.00.

MOISTURE TO CHIMNEY BRICKWORK. 999 IS THE MAXIMUM READING.

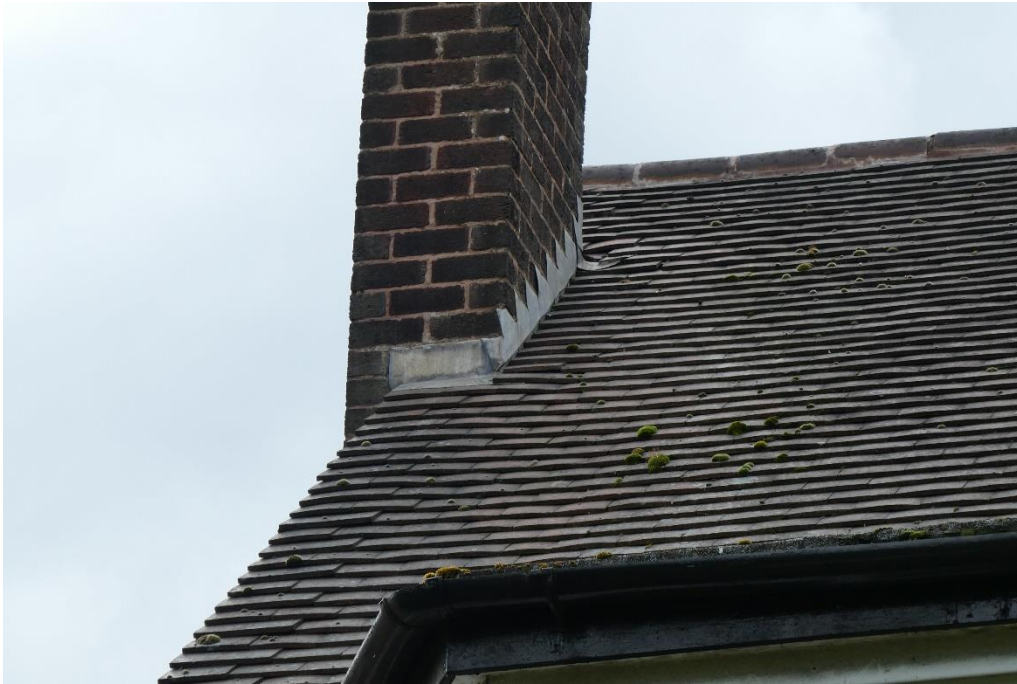
FLASHINGS ARE LOOSE.

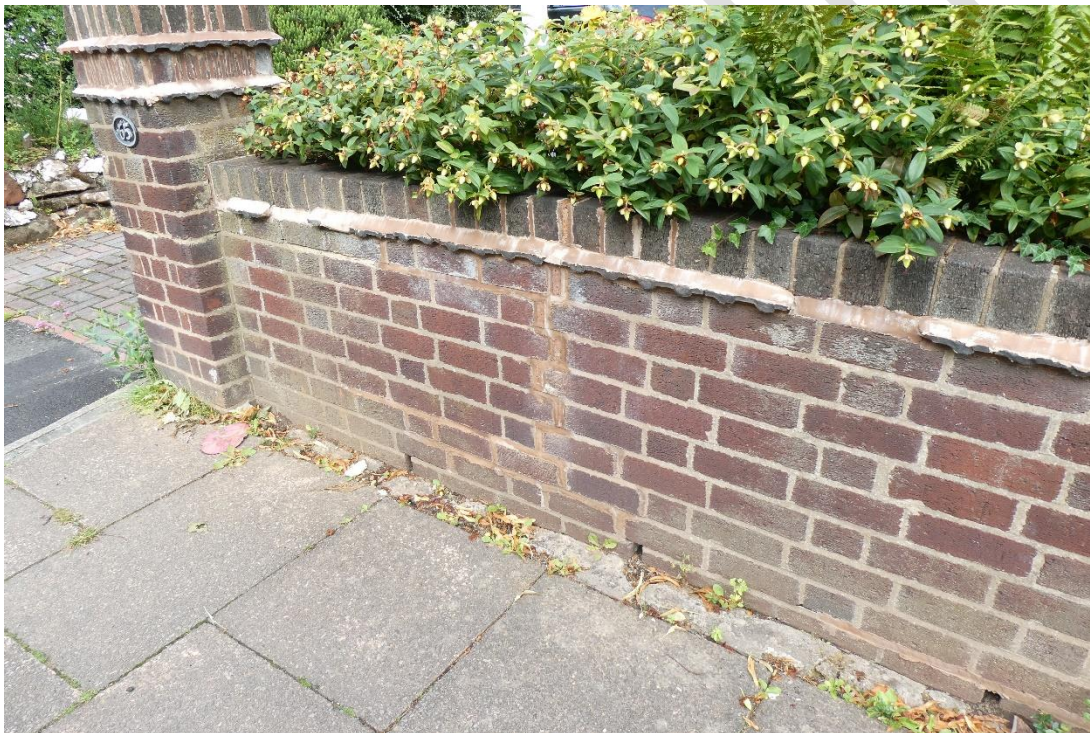
6.02 There is a 225mm retaining wall to the front garden. There are two repointed cracks which indicate lateral failure which is usually caused by tree pressure. There is no tree and there are no obvious stumps to the planted area. We cannot comment further.

REPOINTED CRACK TO FRONT WALL.

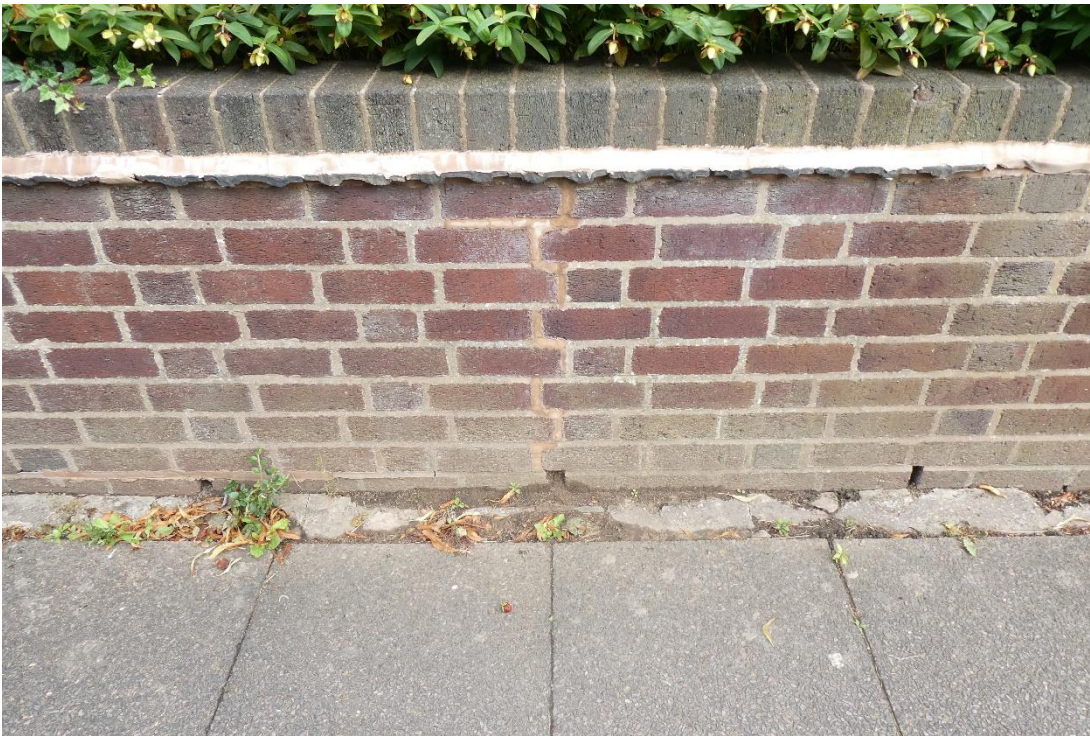
REPOINTED CRACK TO FRONT WALL.

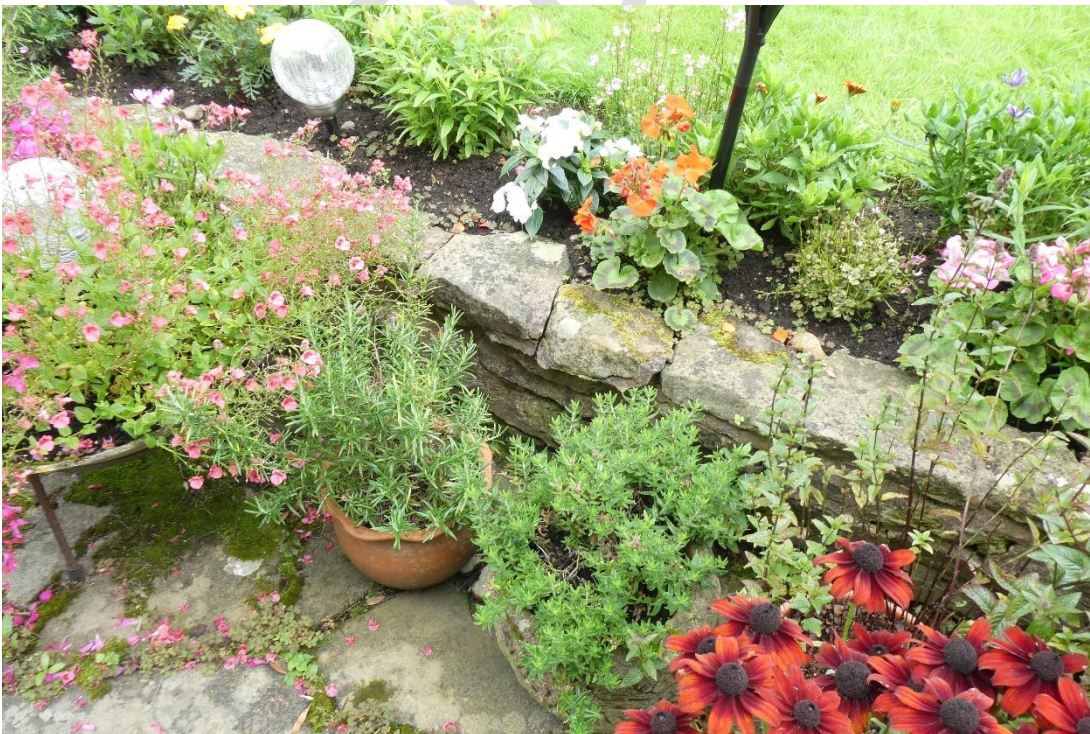
6.03 Around the patio there is a small sandstone wall that retains the lawn. Some of the blocks are loose and need re-bedding.

LOOSE BLOCKS TO REAR WALL.

**Action:** Re-bed loose blocks.

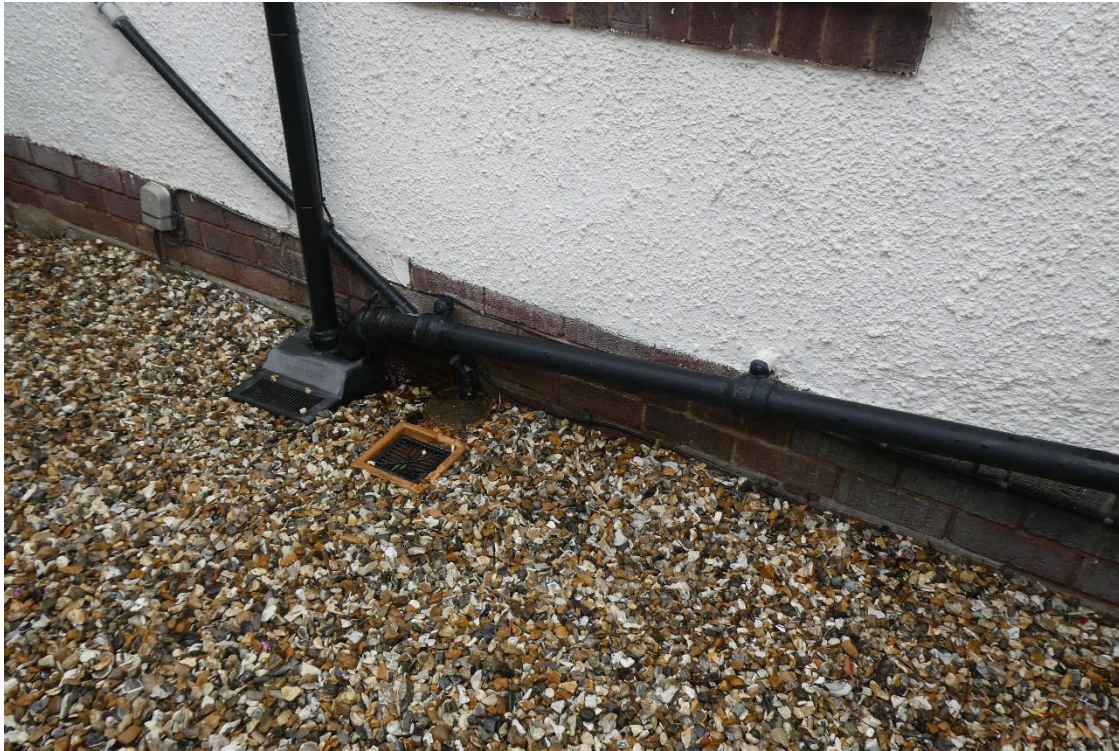
LOUNGE DOWNPIPE LEAKING OUTSIDE OF THE HALL.

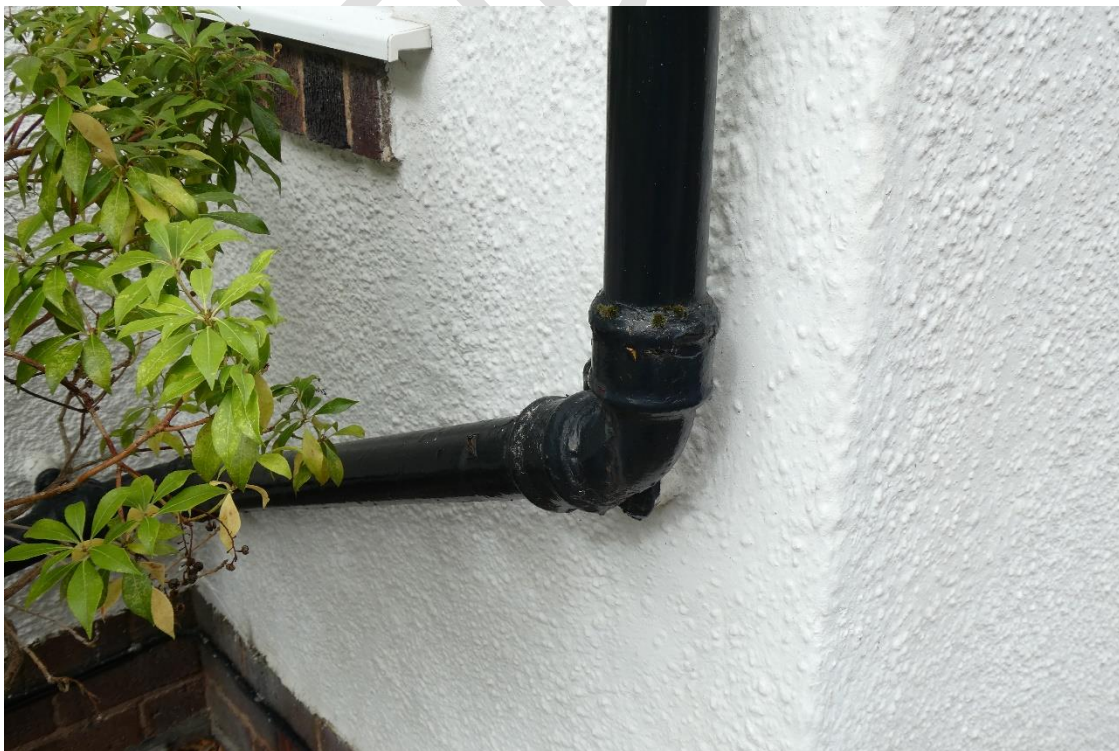
LOUNGE DOWNPIPE JOINT IS IN POOR CONDITION.

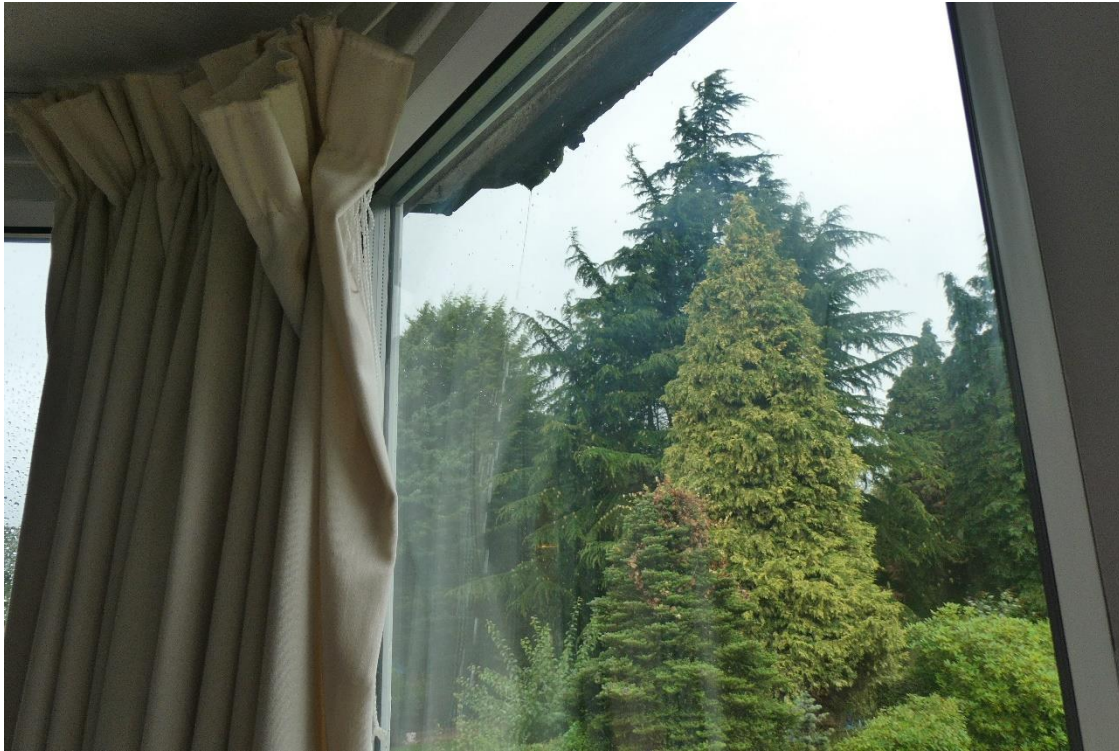
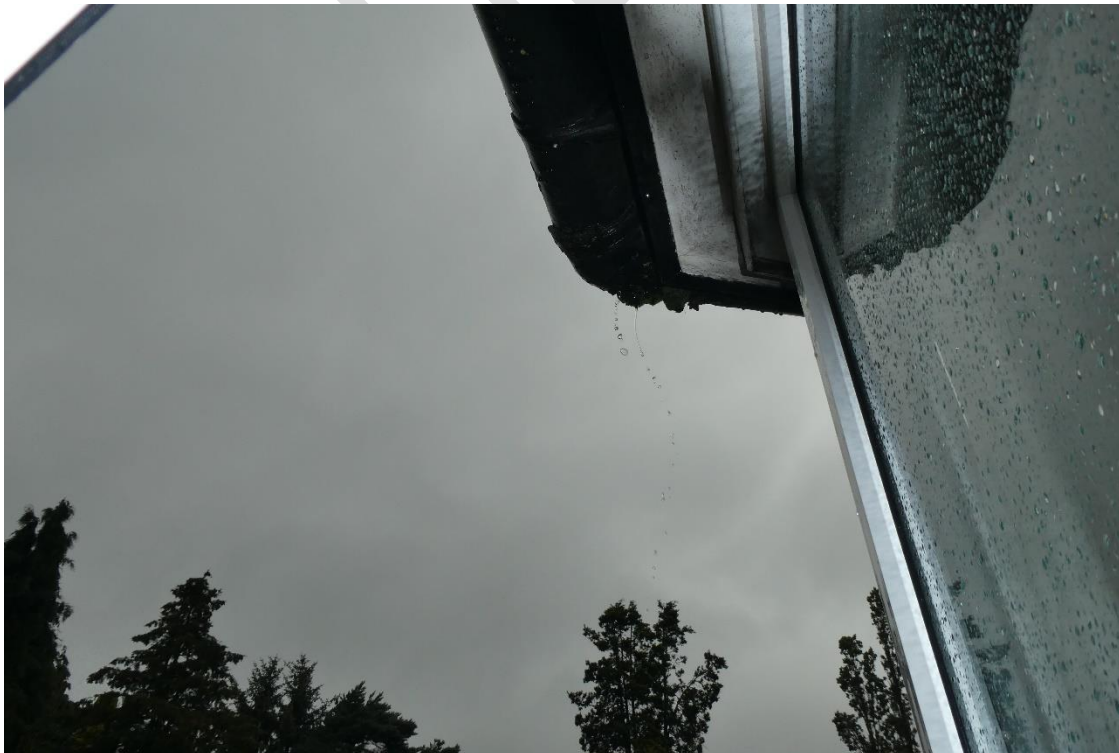
RAINWATER LEAKING OUT OF BEDROOM TWO GUTTER.

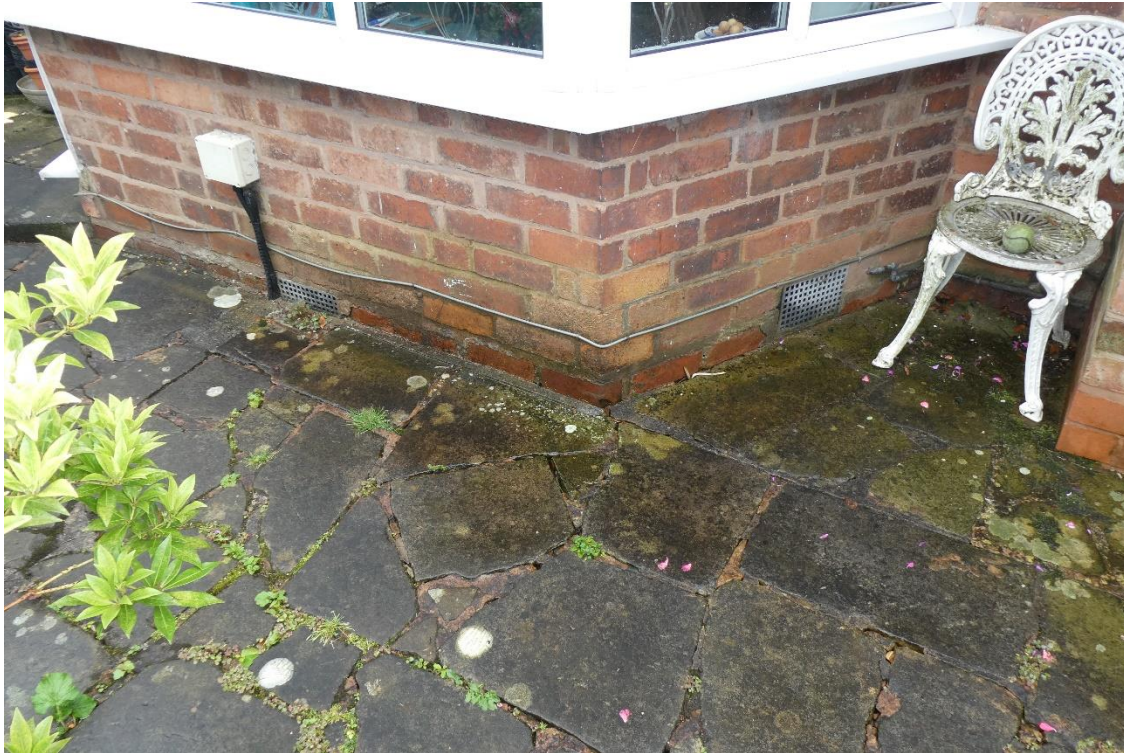
LEAKAGE FROM THE GUTTER TO BEDROOM TWO IS DAMPENING THE BAY BRICKWORK.
