PRIVATE & CONFIDENTIAL REF: 0493/19

BUILDING SURVEY ON \*\*\*\*\*

Date of Survey: Two separate visits – \*\*\*\*\* and \*\*\*\*\*

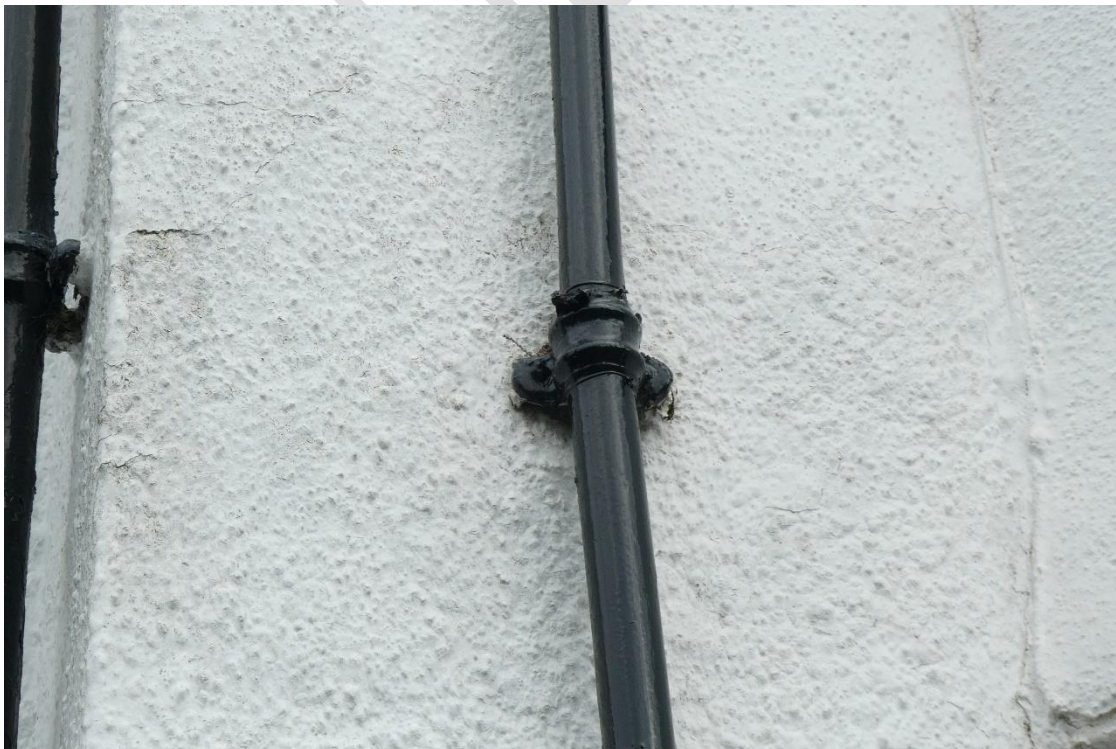
FRONT DOWNPIPE CORRODING AT JOINT.

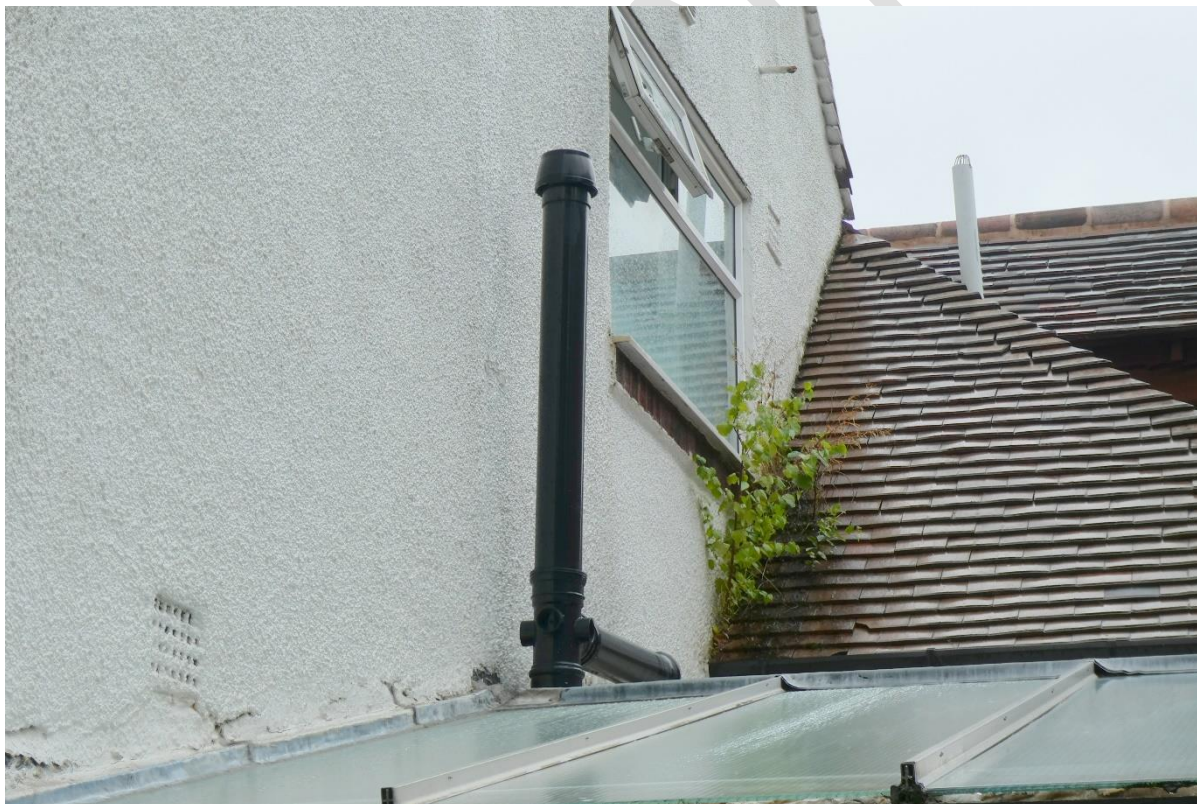
BATHROOM PIPE IS SHORT AND VENTS VIA AN AAV.

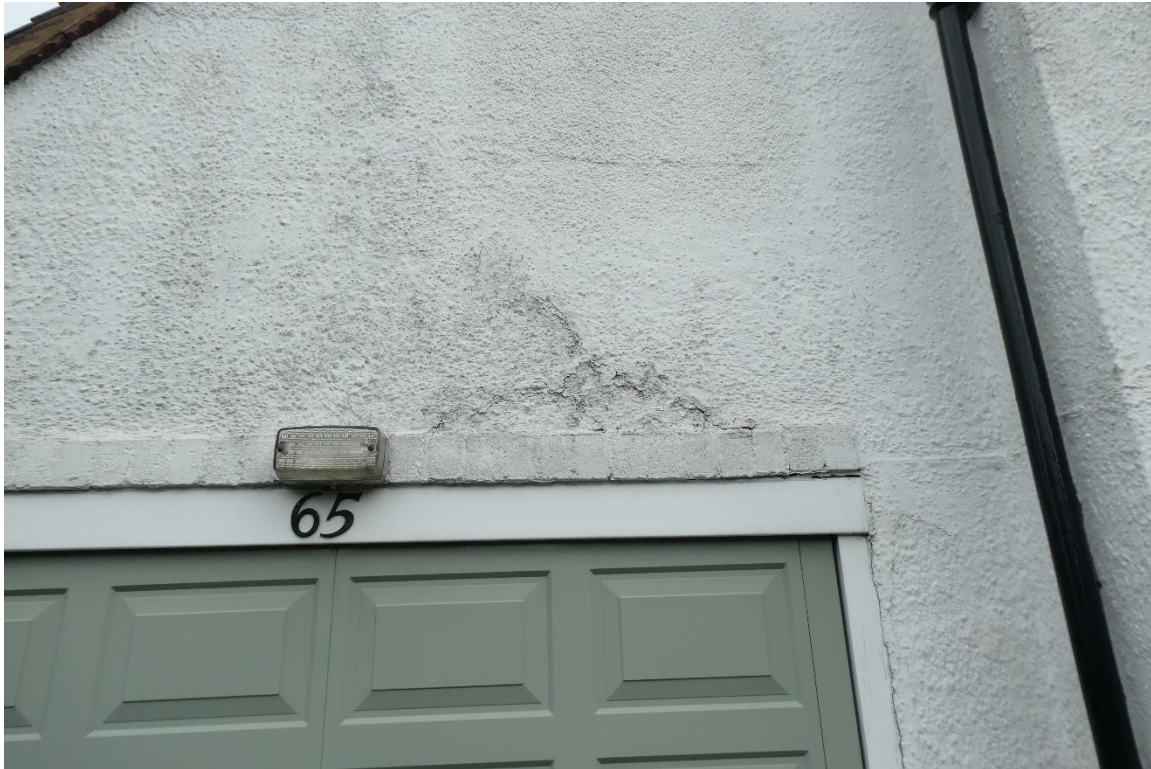
DELAMINATING RENDER AND SETTLEMENT ABOVE GARAGE DOORS.

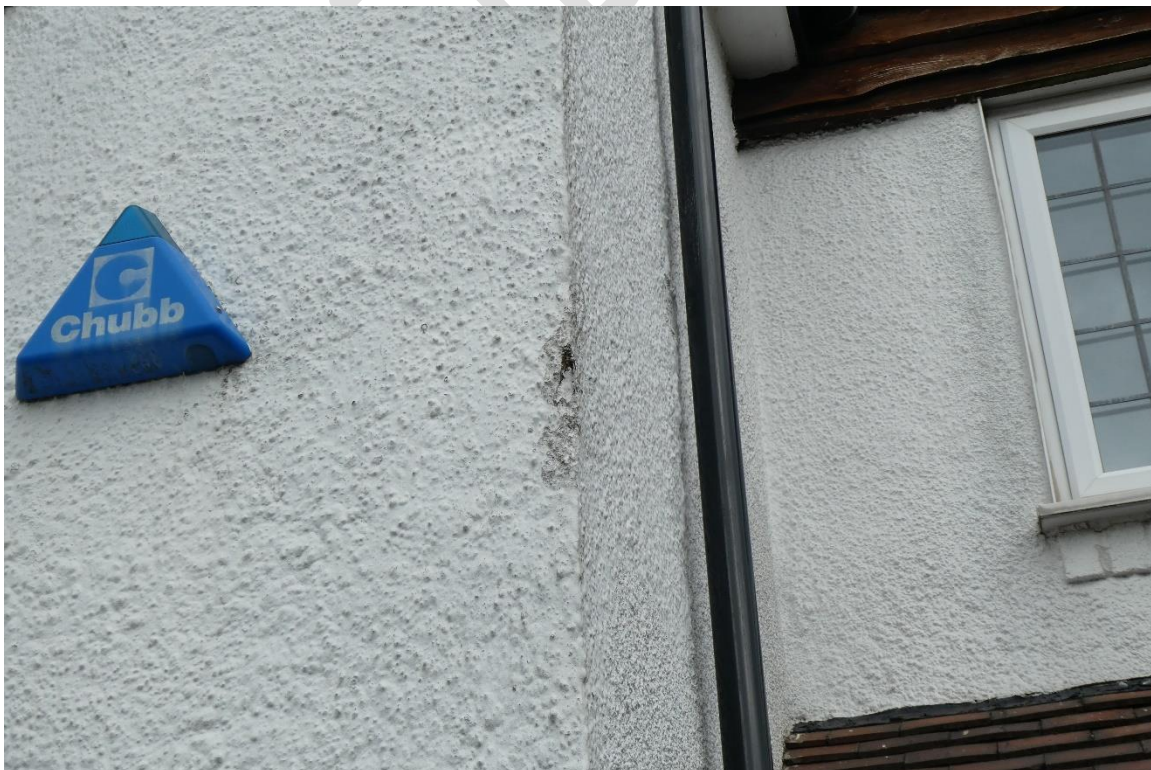
DAMAGE TO RENDER AT FRONT CORNER.

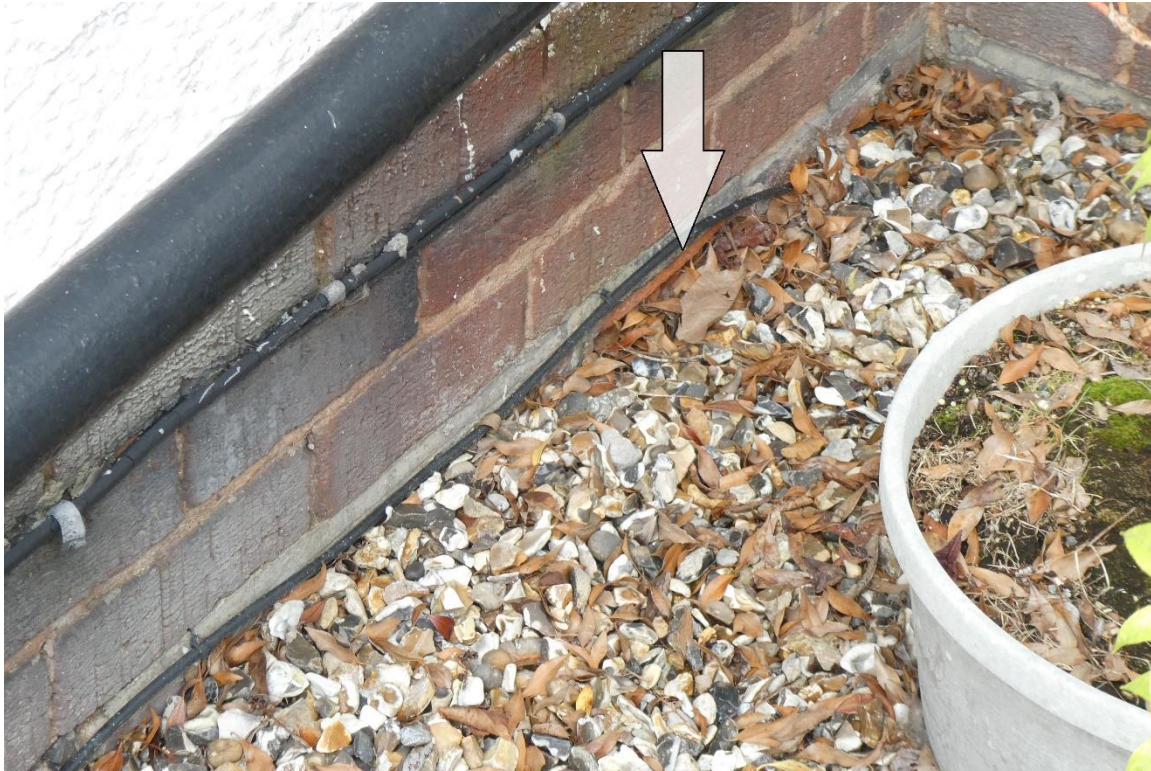
COVERED AIR BRICKS TO THE SIDE.

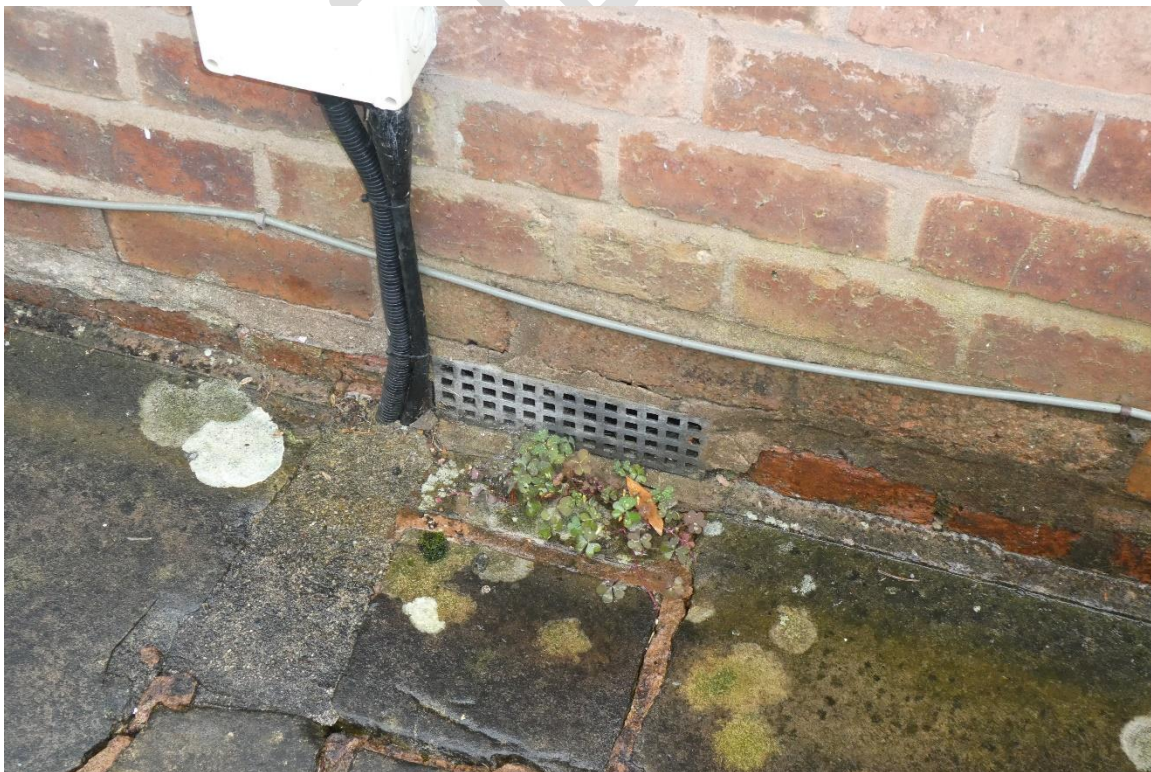
HARDSTANDING TOO CLOSE TO DPC AND COVERED AIR BRICK TO THE REAR BAY.

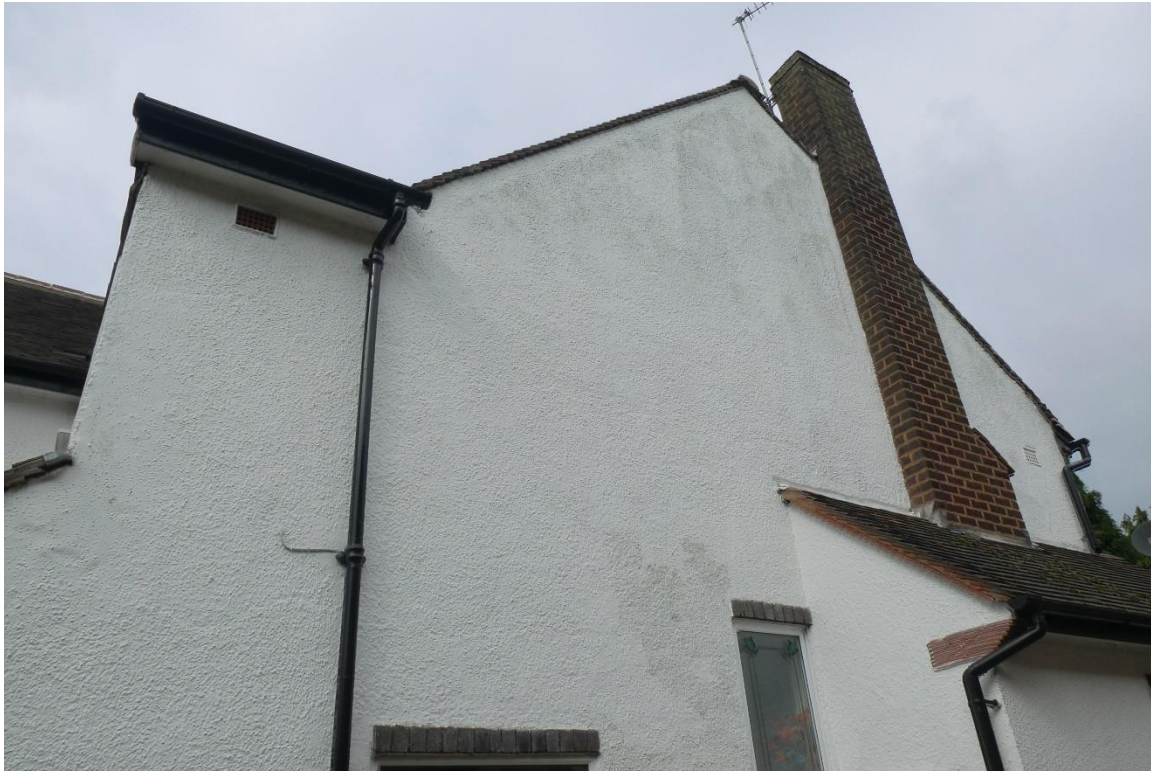
PREVIOUS RENDER REPAIRS/RENEWALS TO WALL ABOVE UTILITY/COVERED AREA.

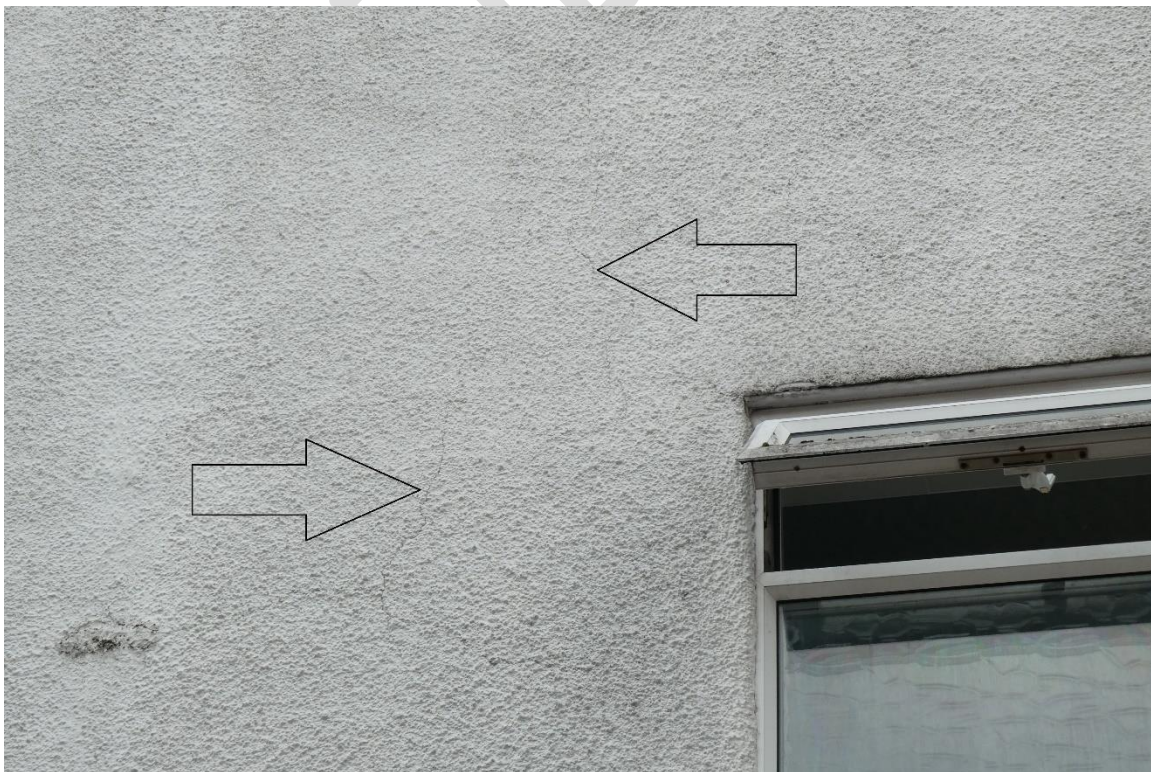
SHRINKAGE CRACKING.

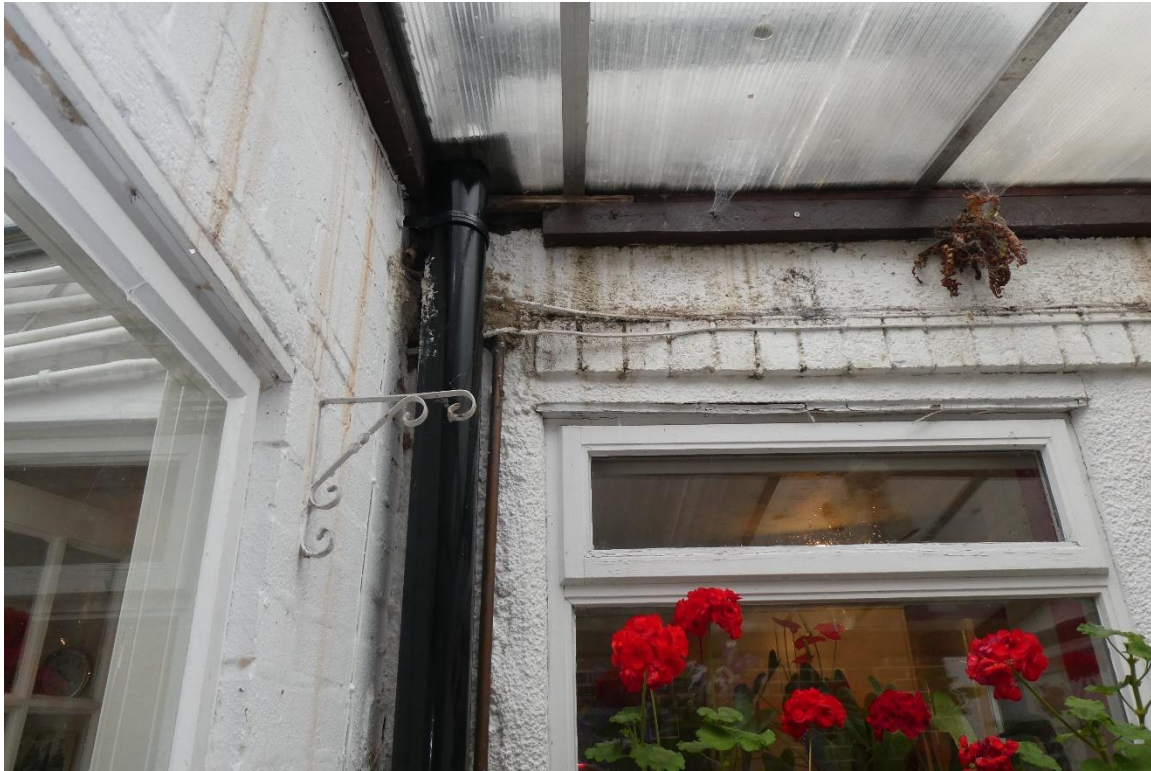
DAMAGE TO WALL DUE TO LEAKAGE THROUGH COVERED AREA.

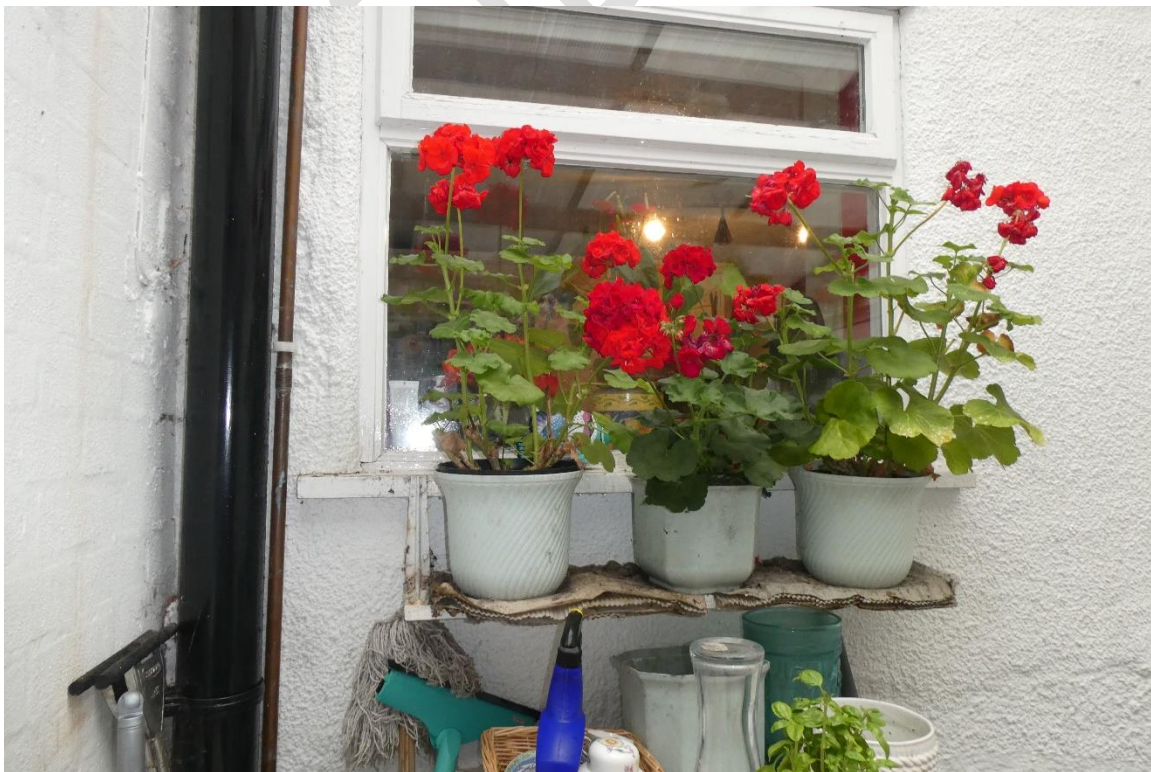
ALL OF THIS WALL IS BECOMING DAMP.

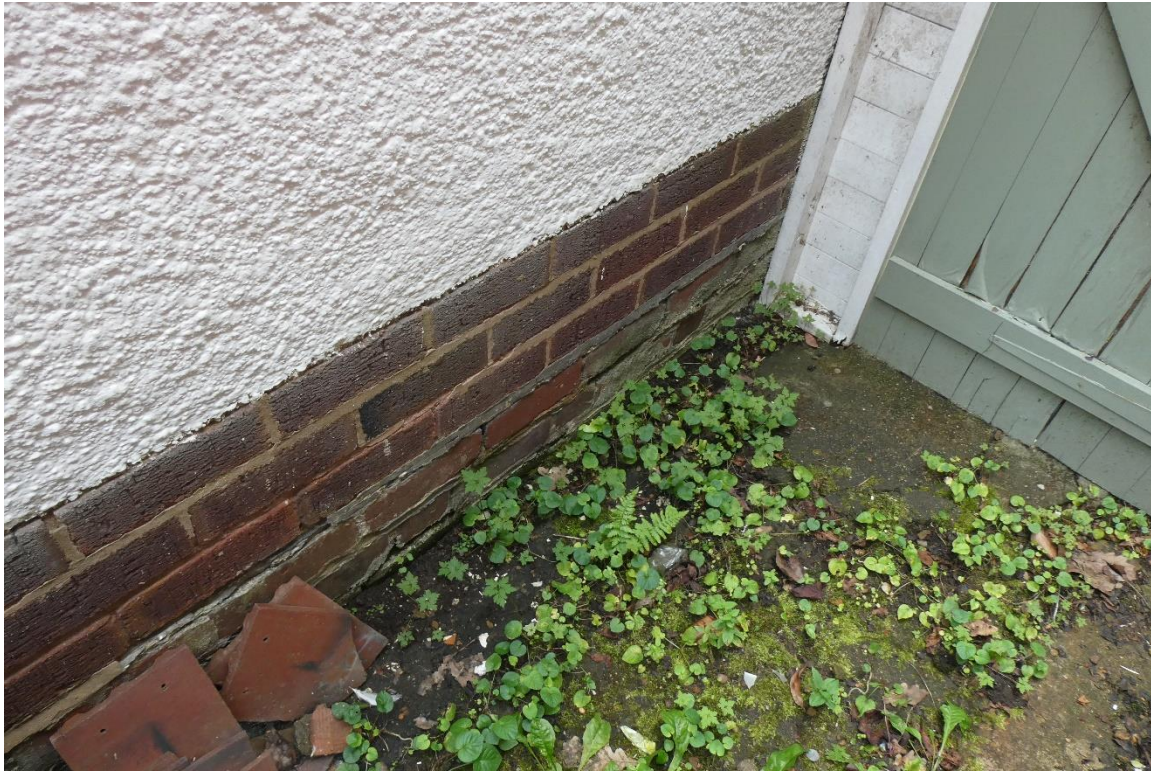
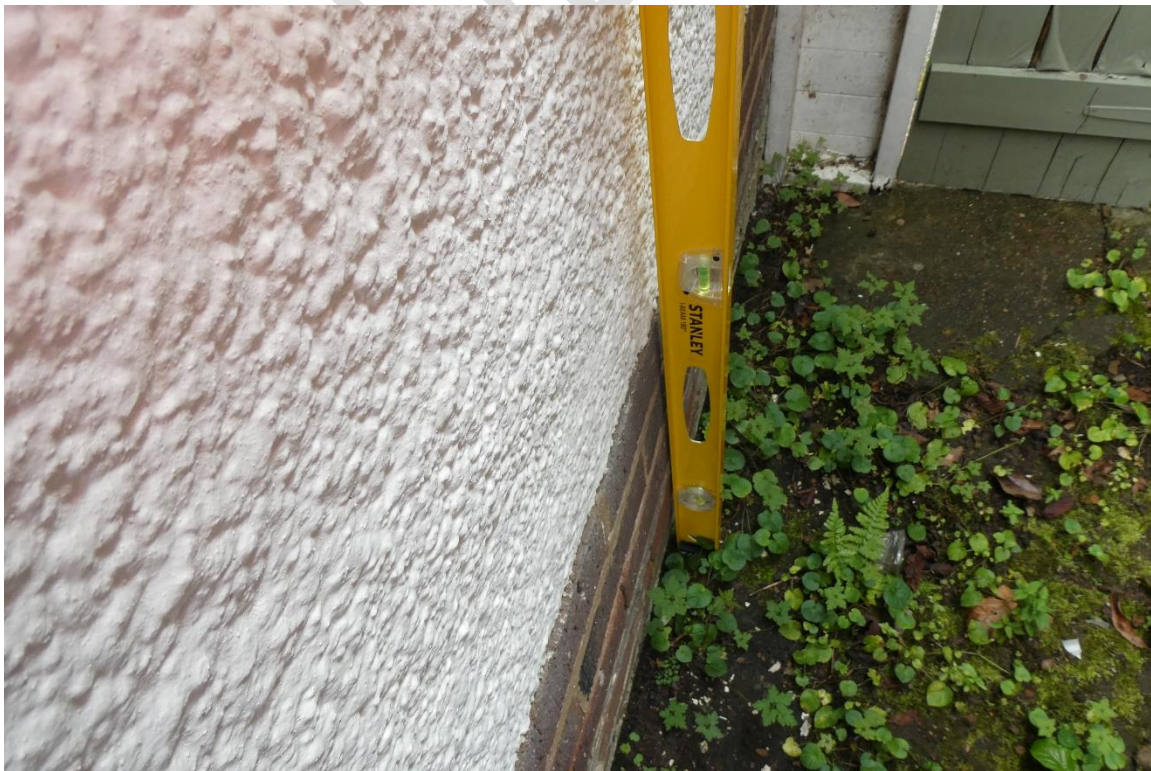
- The side wall of the garage is being pushed out by the expansive forces of sulphate attack to the garage slab (see section 17.00).
- The internal face of the garage walls are badly damp damaged.

GARAGE WALL IS BEING PUSHED OUT BY SULPHATE ATTACK TO THE GARAGE SLAB.

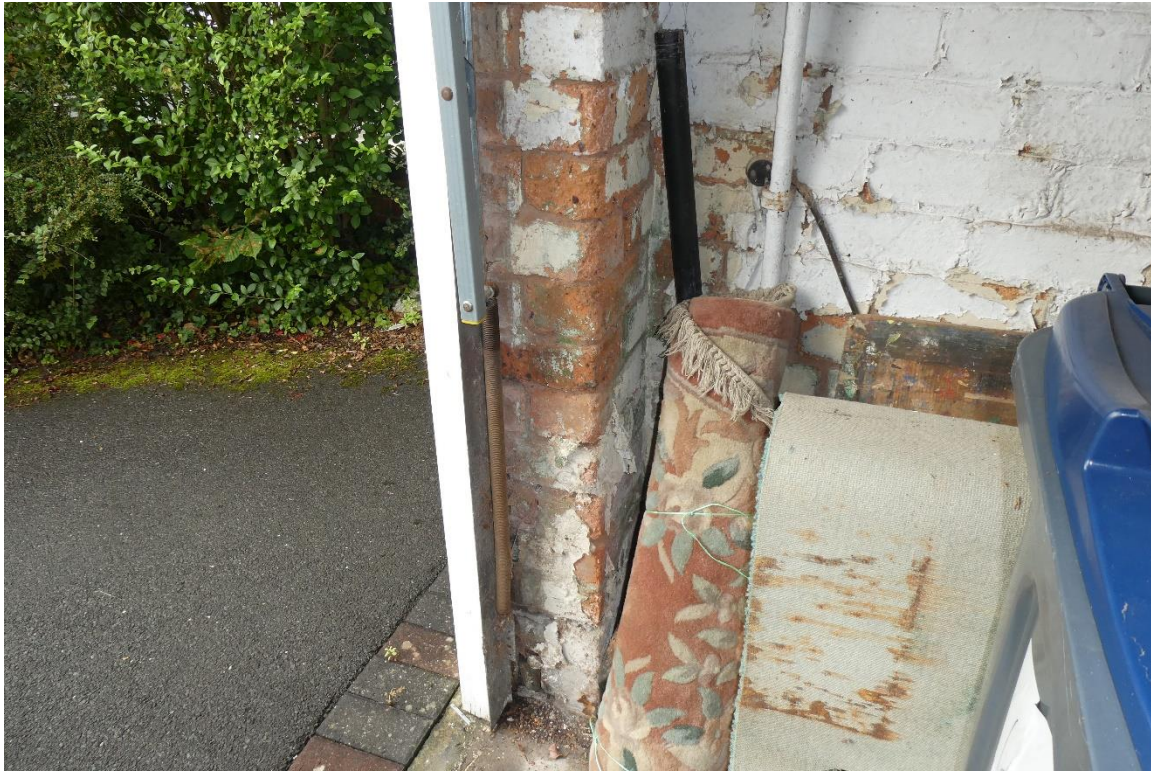
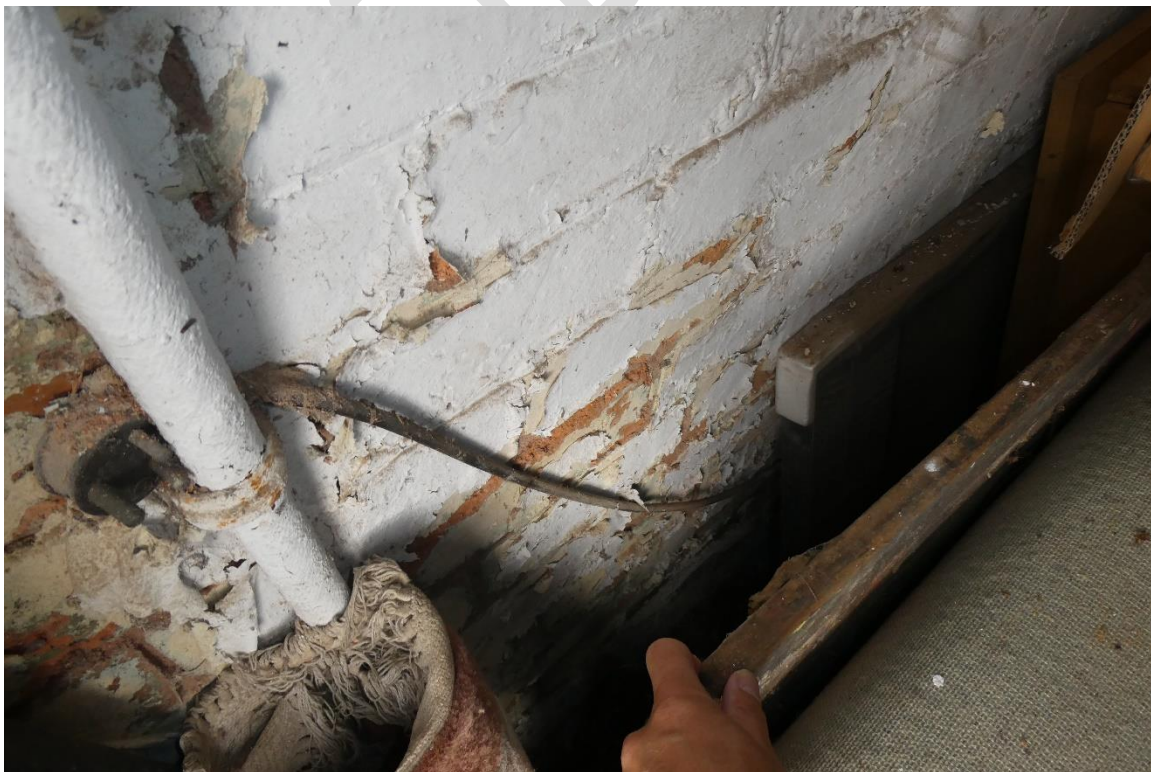
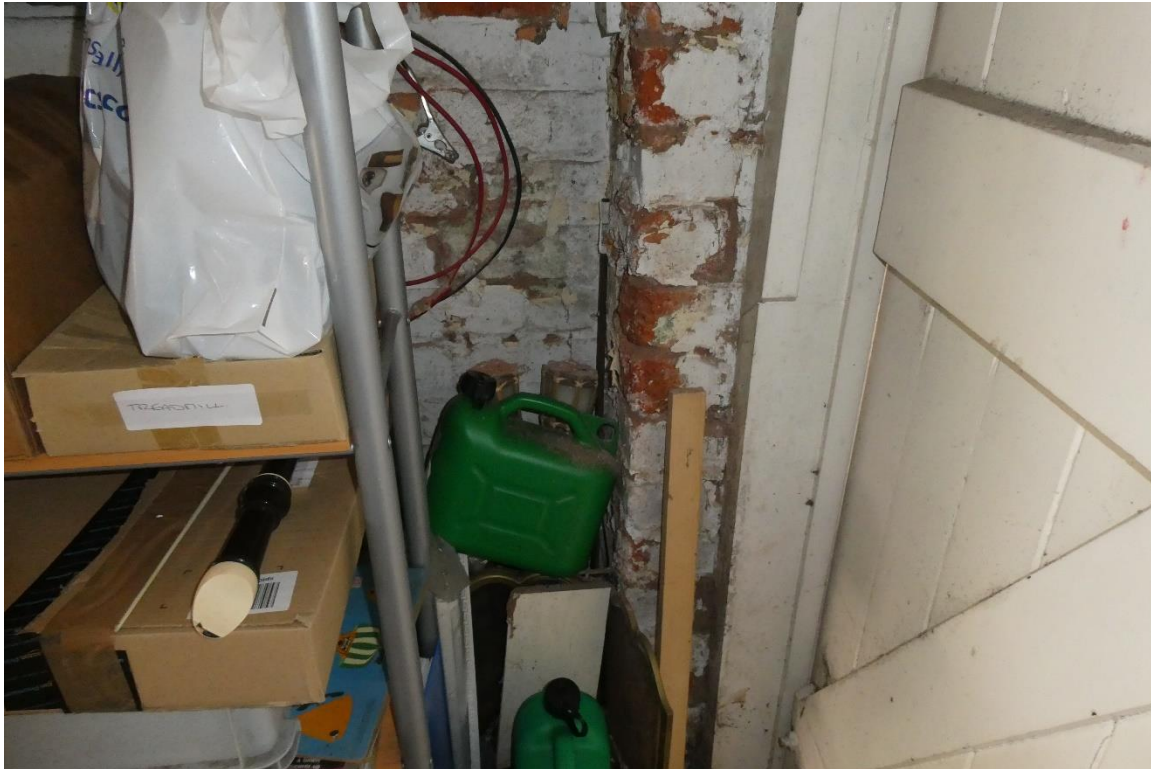
GARAGE WALLS ARE BADLY DAMAGED.

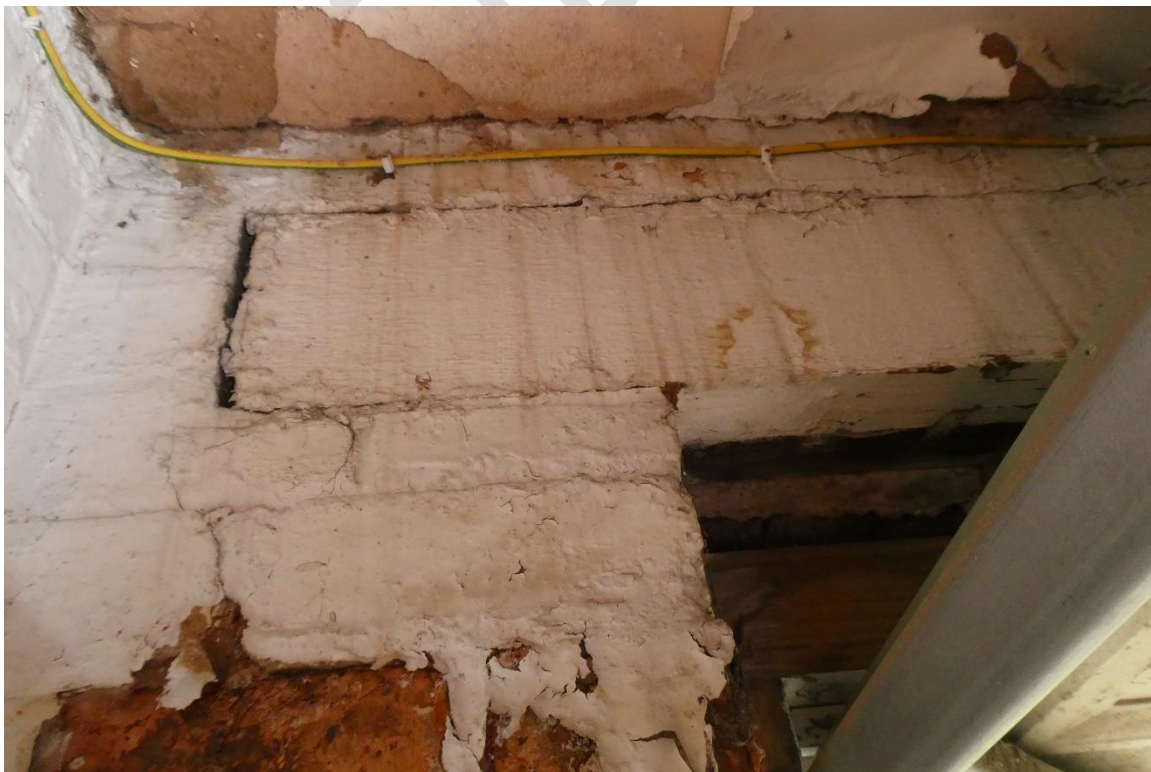
LINTEL TO INSIDE OF GARAGE DOOR OPENING.

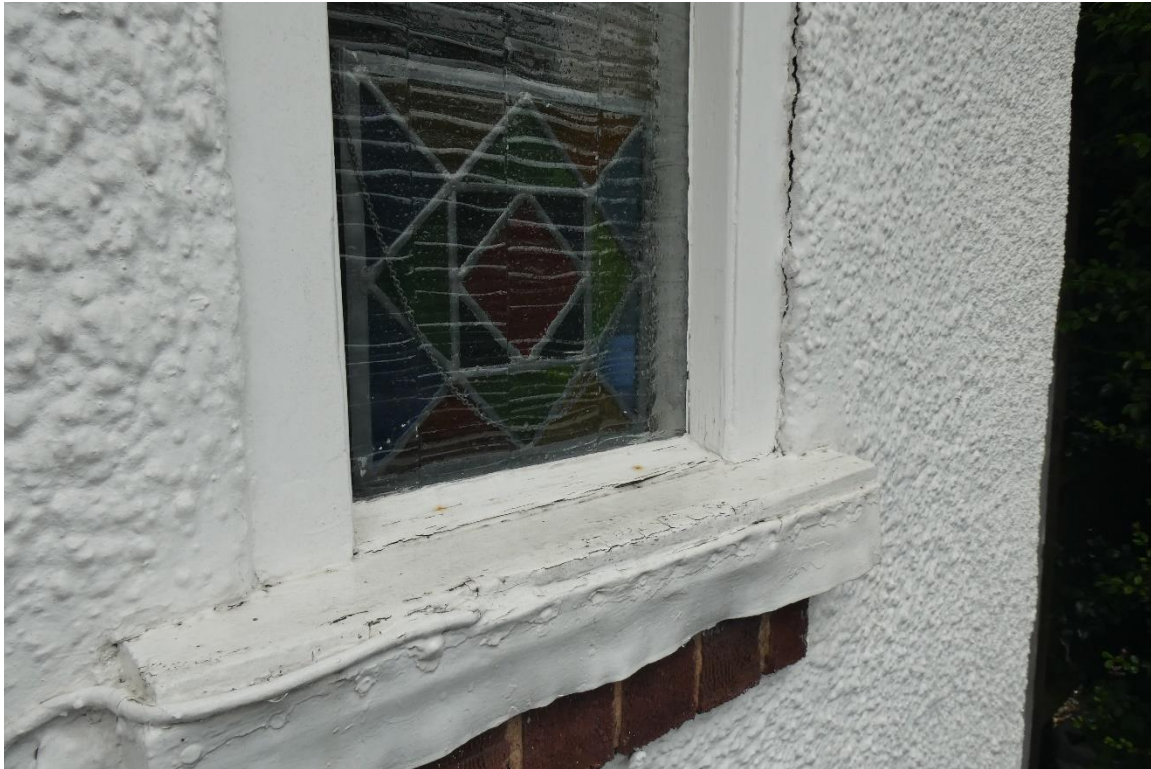
- Stairwell: Positioned where a person could fall against it. The unit is not toughened; safety film should be applied.
- WC: Timber window with leaded glass. The frame is starting to rot through lack of decoration.

WC WINDOW.

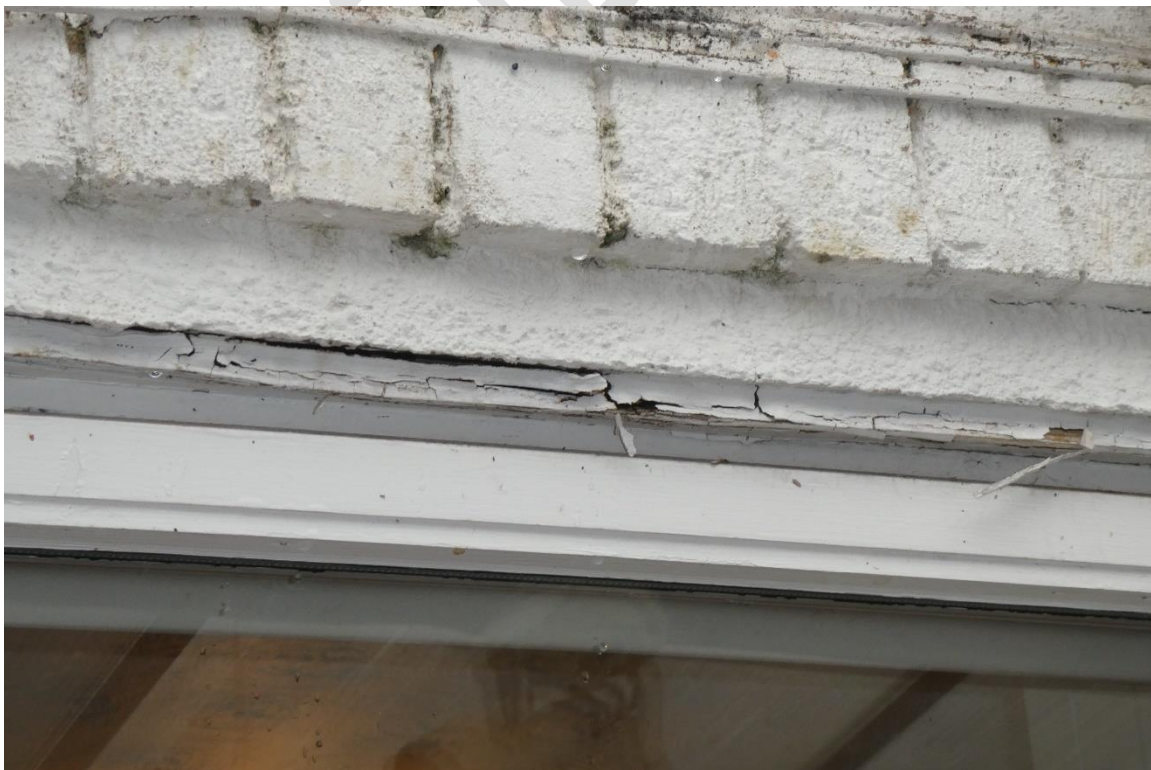
- Kitchen: The side window is timber and due to leakage from the roof, the frame is rotting. It may require renewal.
- Bathroom: Failed main unit which requires renewal.

ROT TO HEAD OF KITCHEN WINDOW.

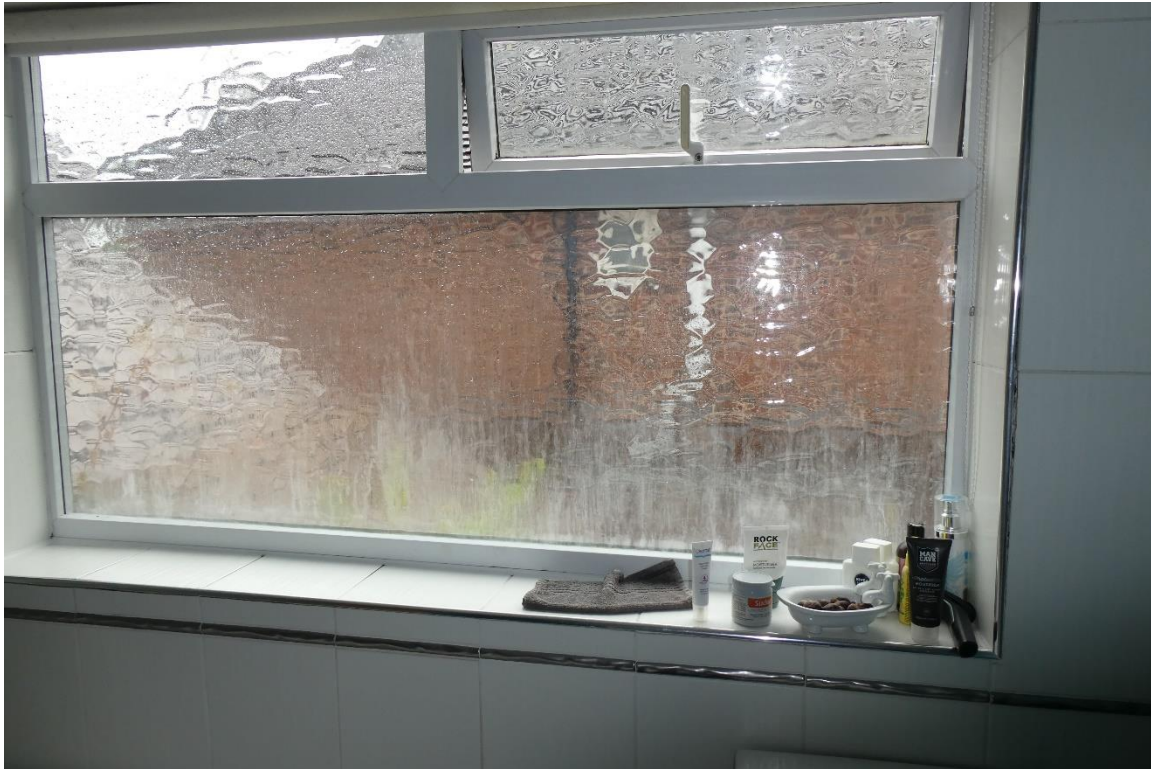
FAILED UNIT TO BATHROOM WINDOW.

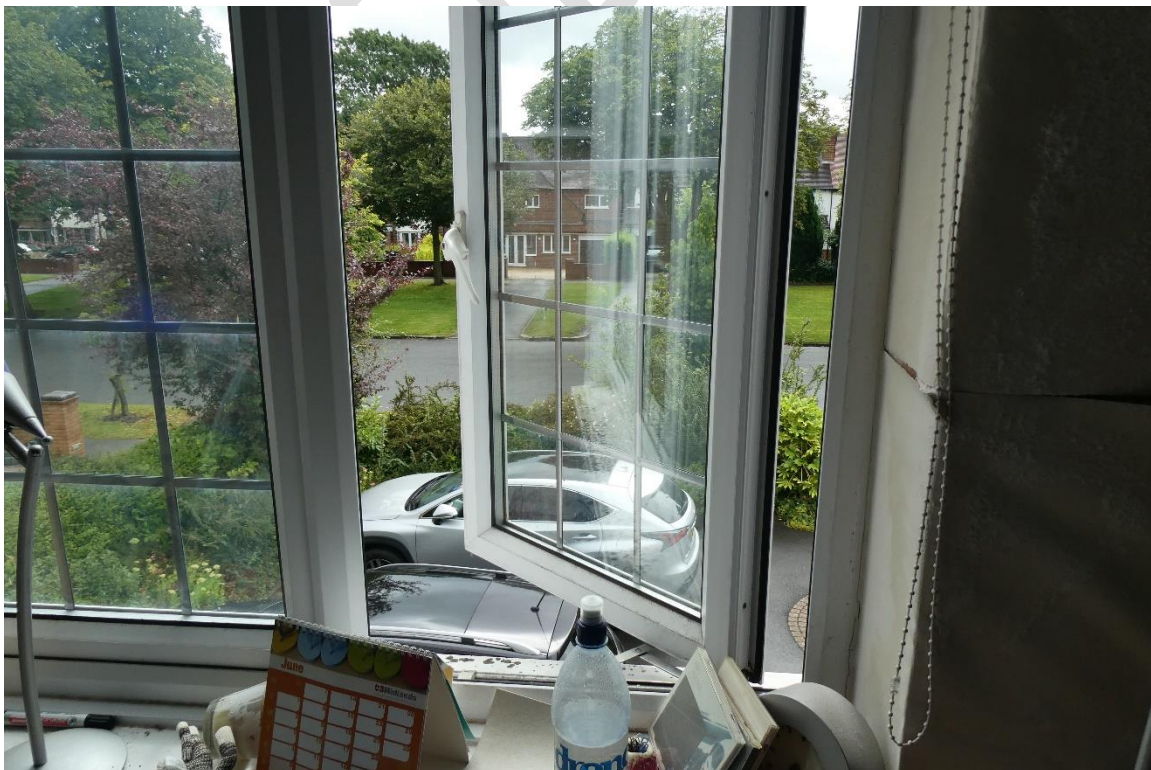
- Front bedroom four: The casement opens across the opening and stops half-way. To comply with escape regulations, it should achieve a clear opening of 450mm. The hinges should be replaced with egress hinges.

BEDROOM FOUR STOP ACROSS OPENING.

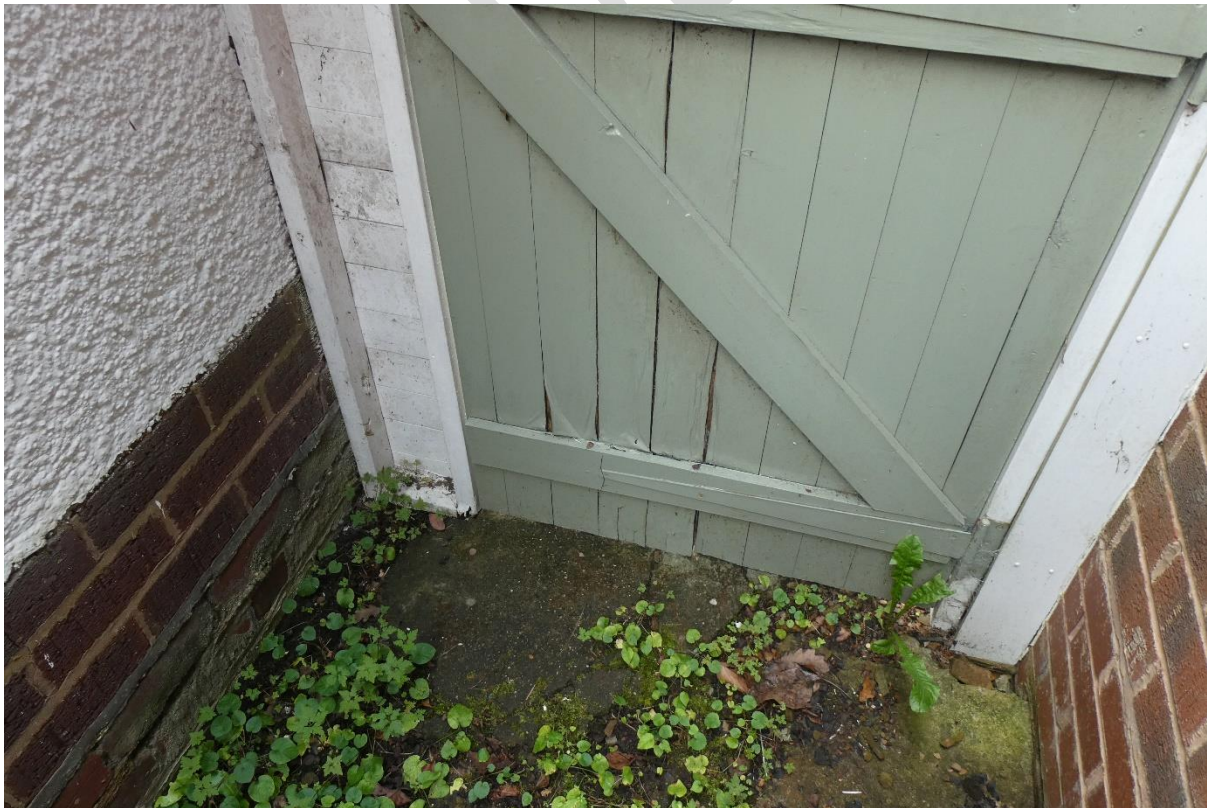
SIDE GATE IS ROTTING.

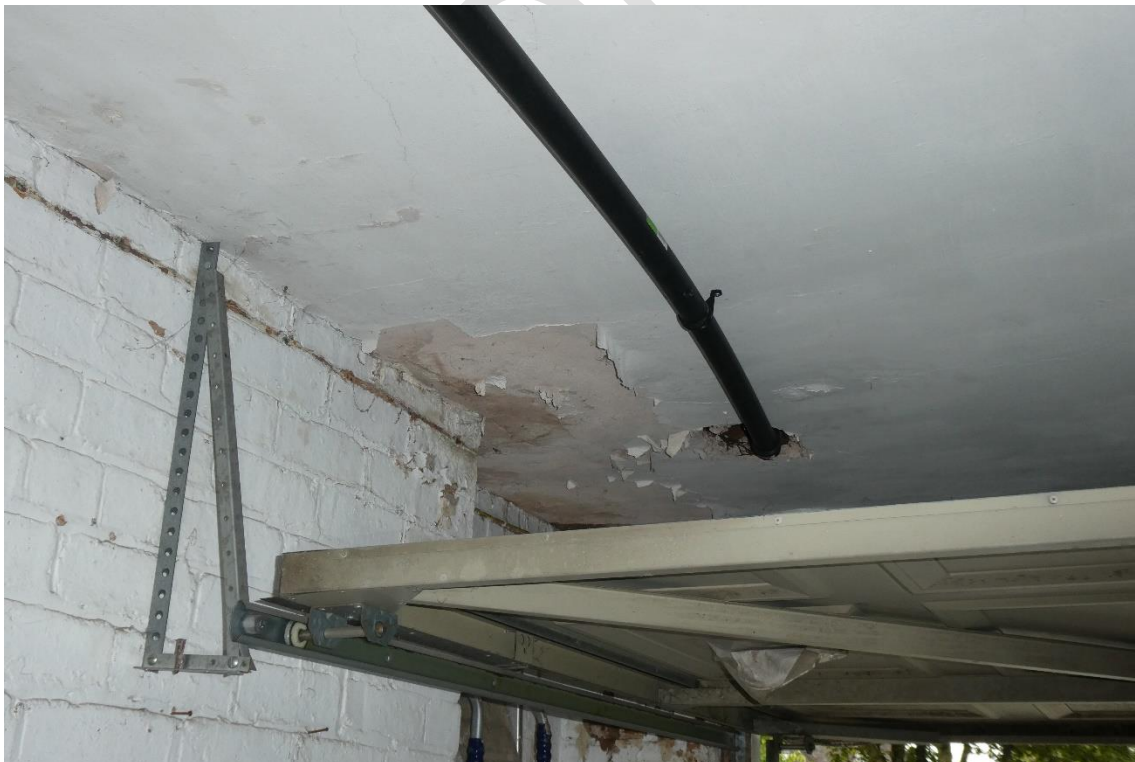
- Damage to garage ceiling beneath the ensuite is again, indicative of leakage and your solicitor should enquire to see if a repair has been carried out.

### DAMAGE TO GARAGE CEILING.

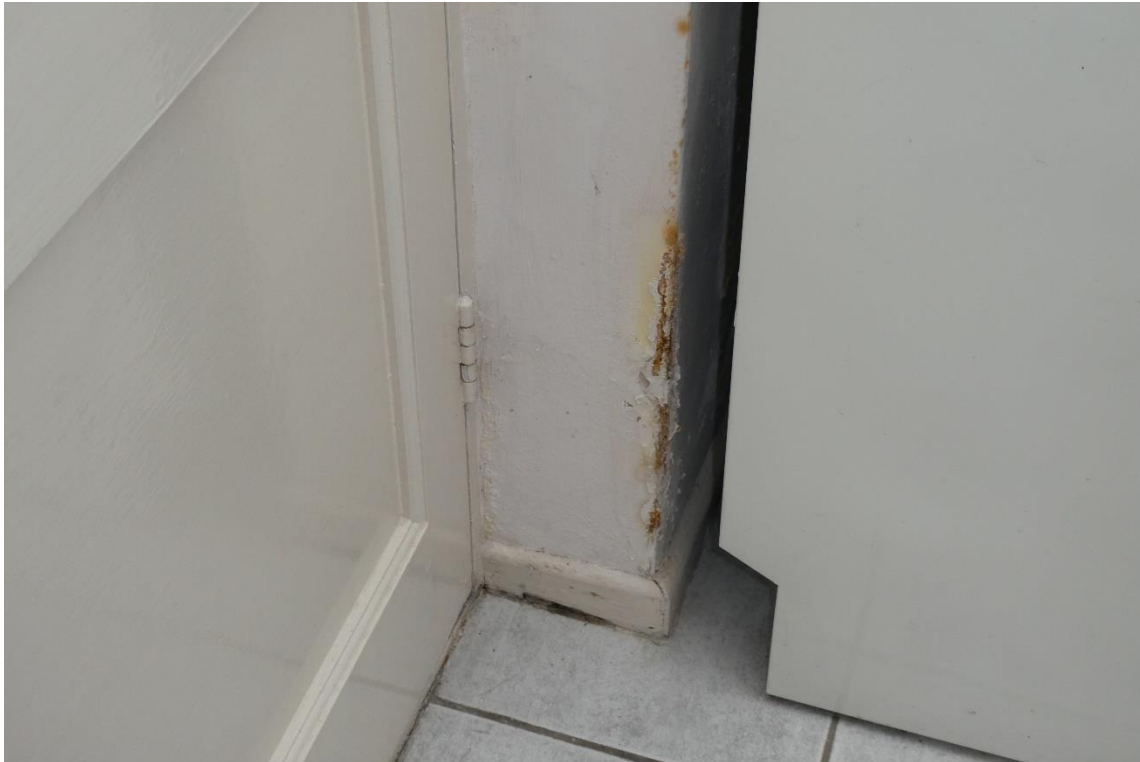
DAMP DAMAGE TO UTILITY WALL.

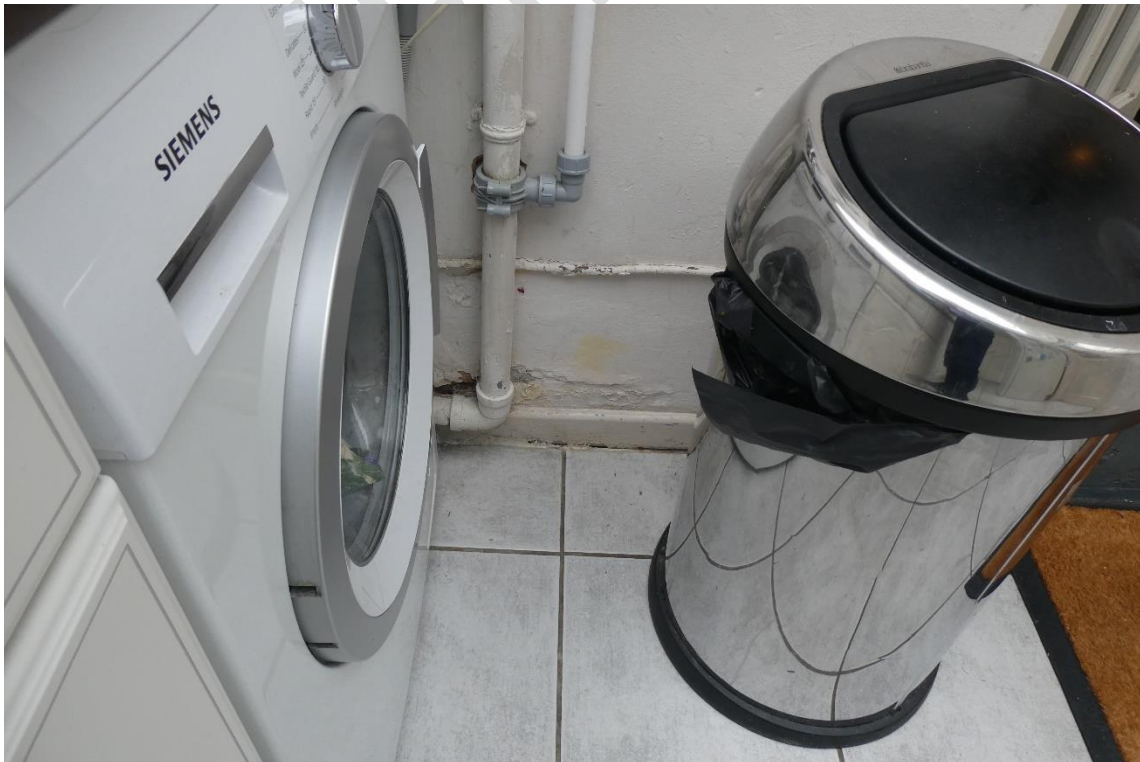
DAMP DAMAGE TO KITCHEN WALL WITHIN UTILITY.

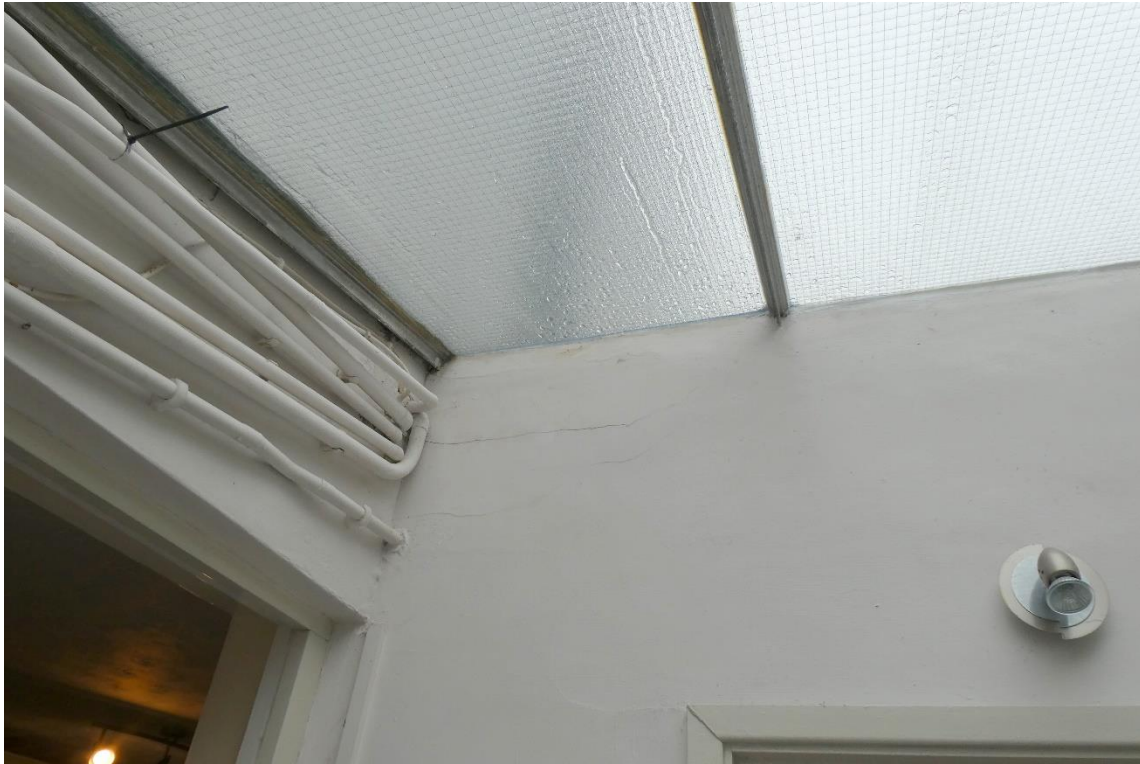
DAMP STAINING BELOW PARAPET WALL TO UTILITY.
