PRIVATE & CONFIDENTIAL REF: 0493/19

BUILDING SURVEY ON \*\*\*\*\*

Date of Survey: Two separate visits – \*\*\*\*\* and \*\*\*\*\*

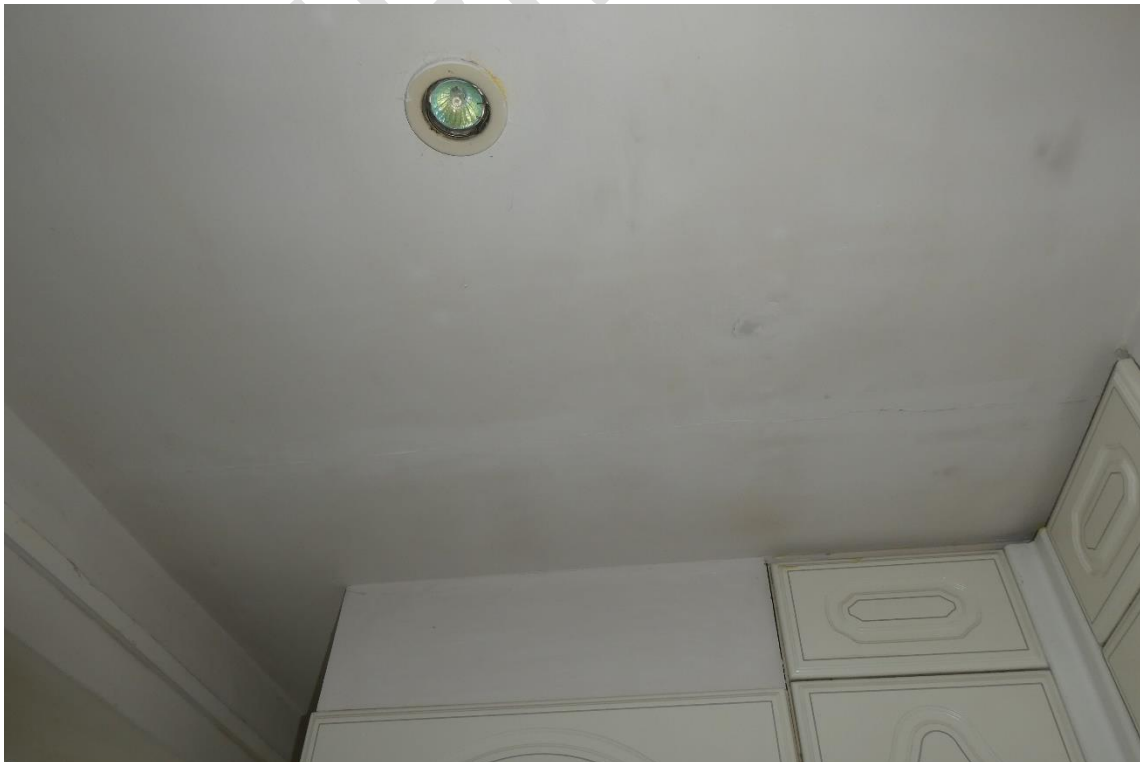
SHADING TO UTILITY CEILING. IS IT DAMP OR POOR REDECORATION?

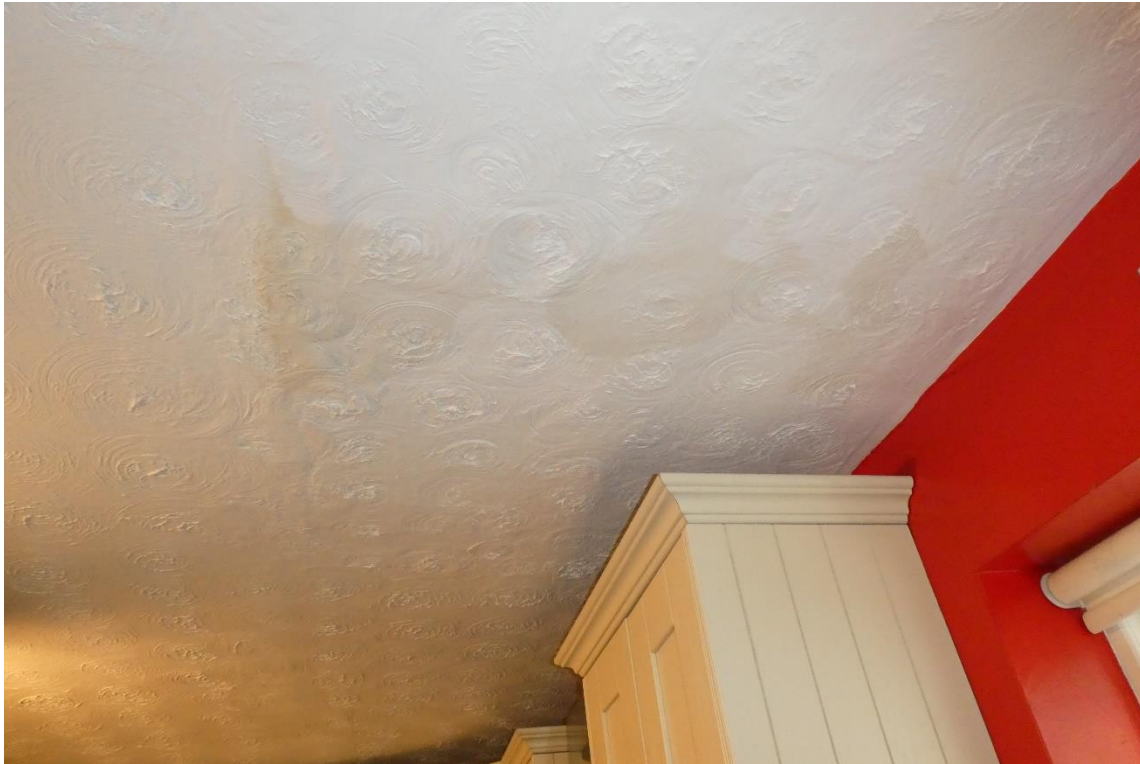
- Damp damage to the kitchen ceiling beneath the bathroom and to the wall above the window. The vendor indicated that a leak to the bathroom had been repaired. Your solicitor should obtain the guarantee.

DAMP THROUGH KITCHEN CEILING.

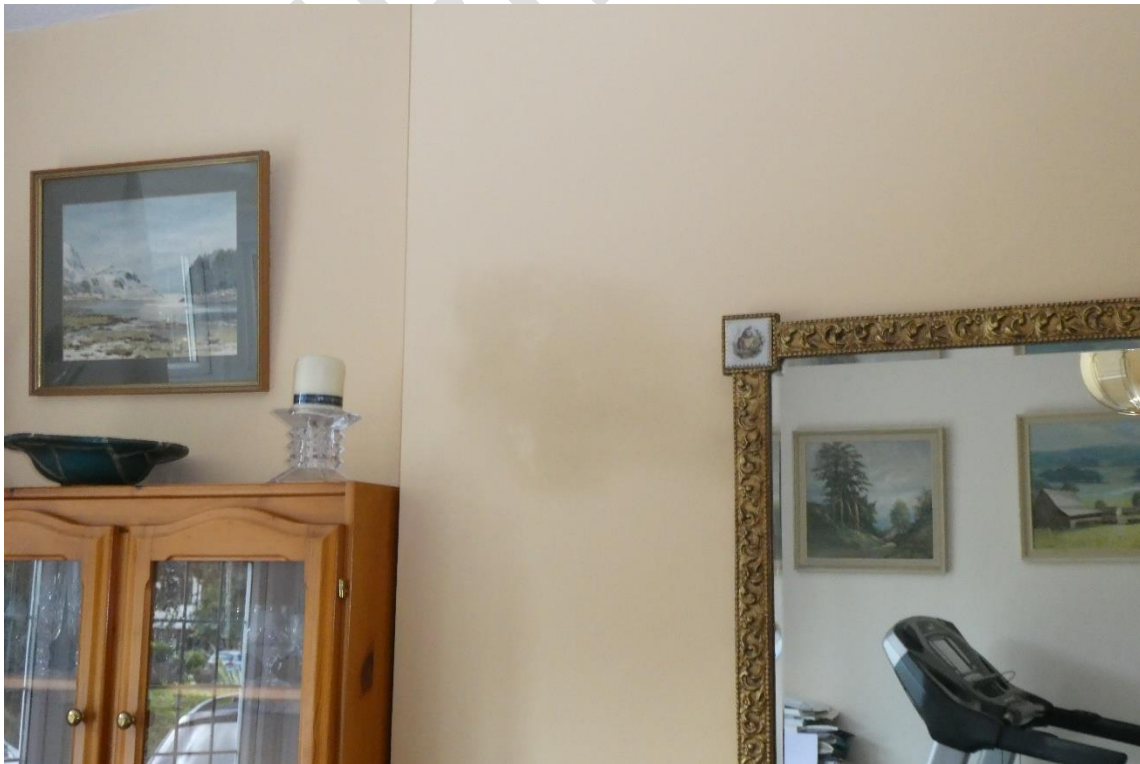
DAMP THROUGH DINING ROOM CHIMNEY BREAST.

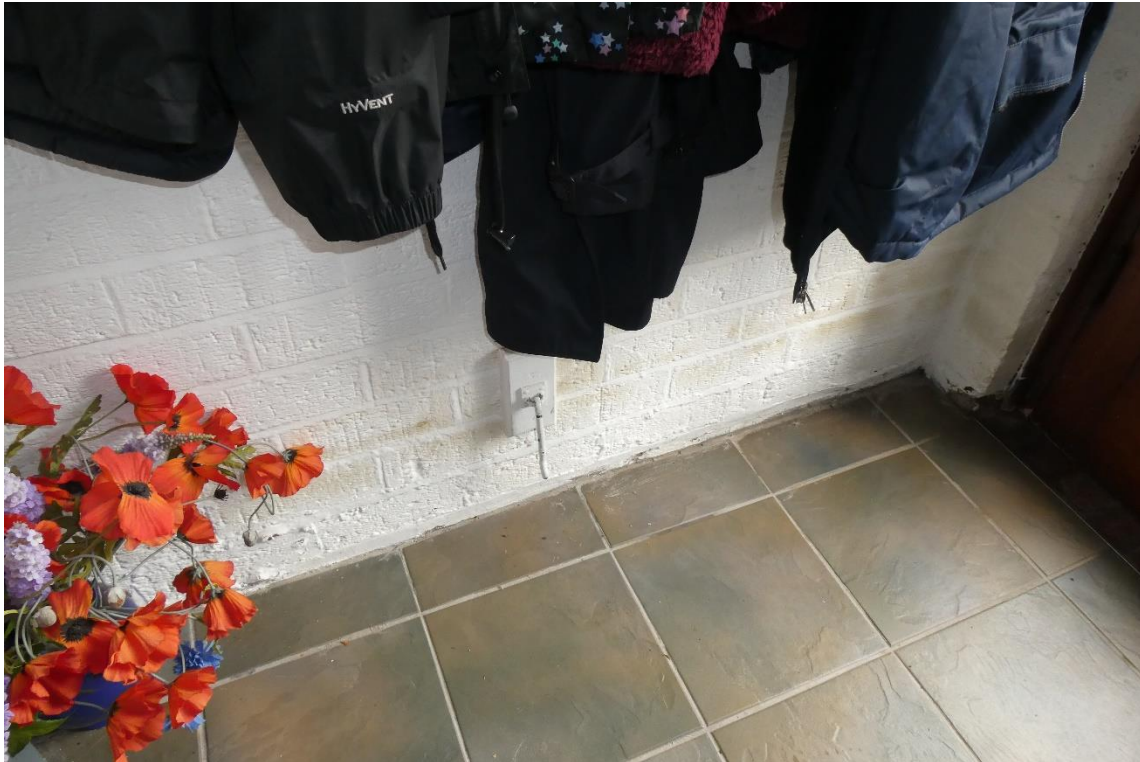
DAMP AT LOW LEVEL TO PORCH.

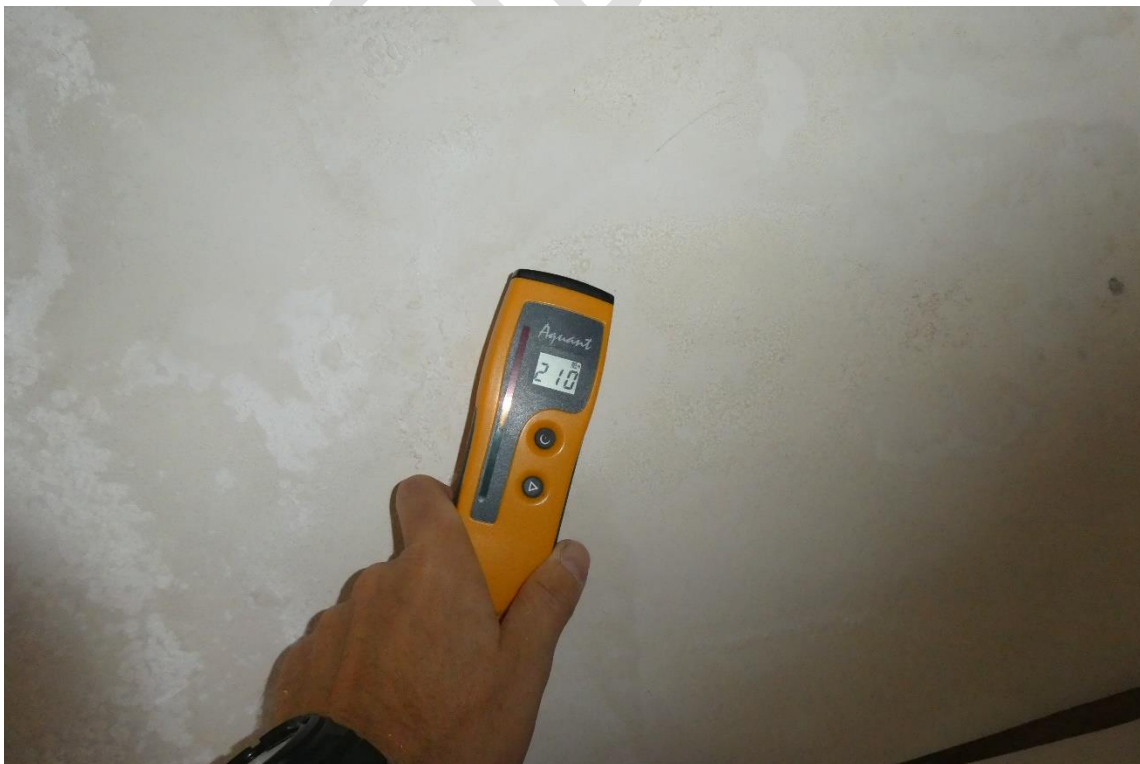
DAMP THROUGH BEDROOM FOUR IS RELATIVELY DRY.

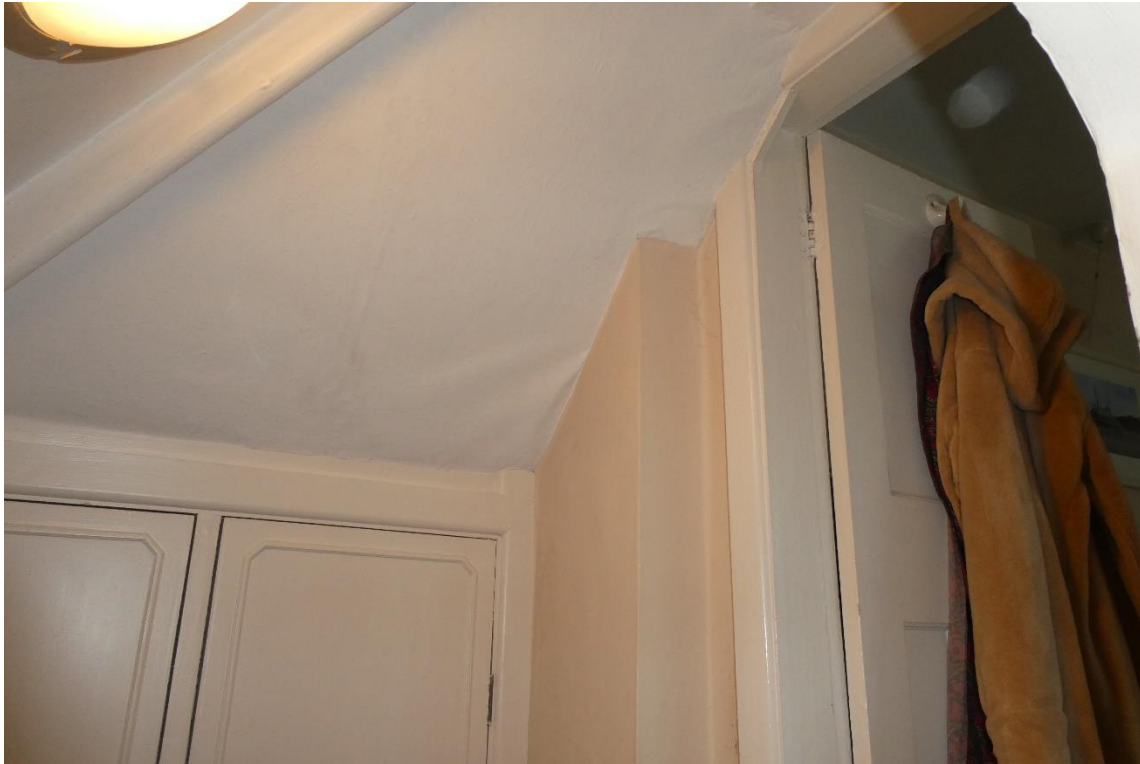
LOOSE WALLPAPER. MAY INDICATE ROOF LEAKAGE.

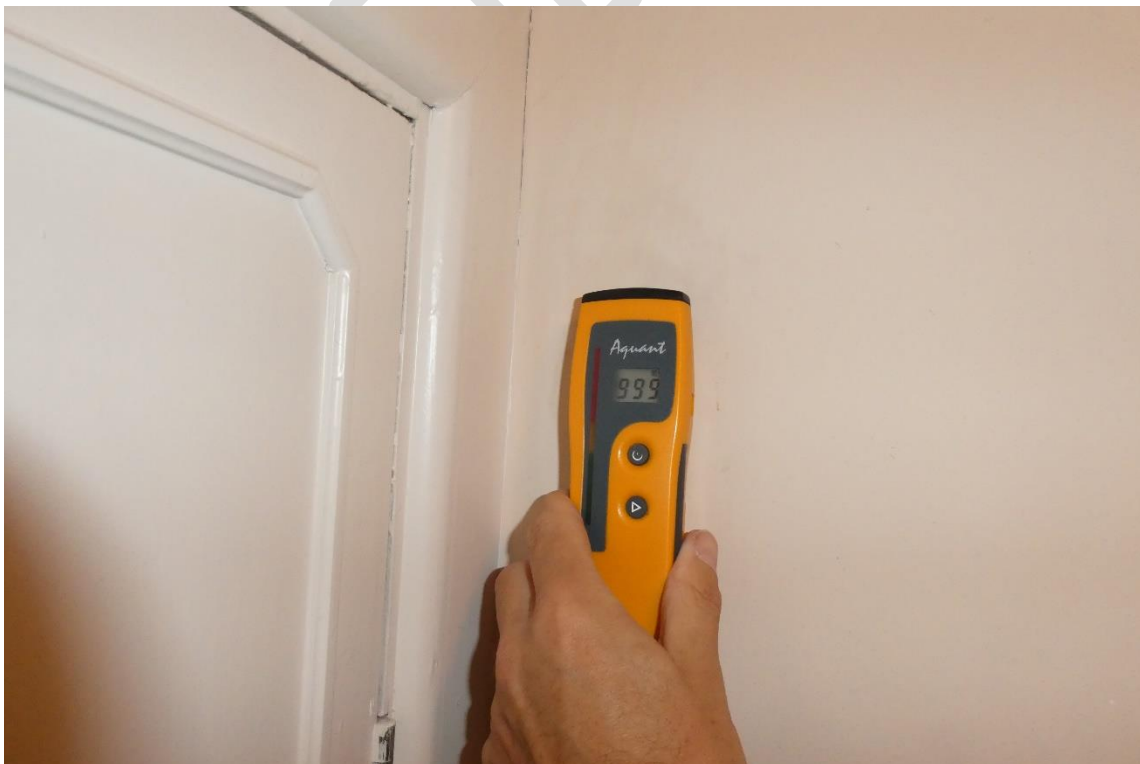
DAMP THROUGH WALL BELOW THE AREA.

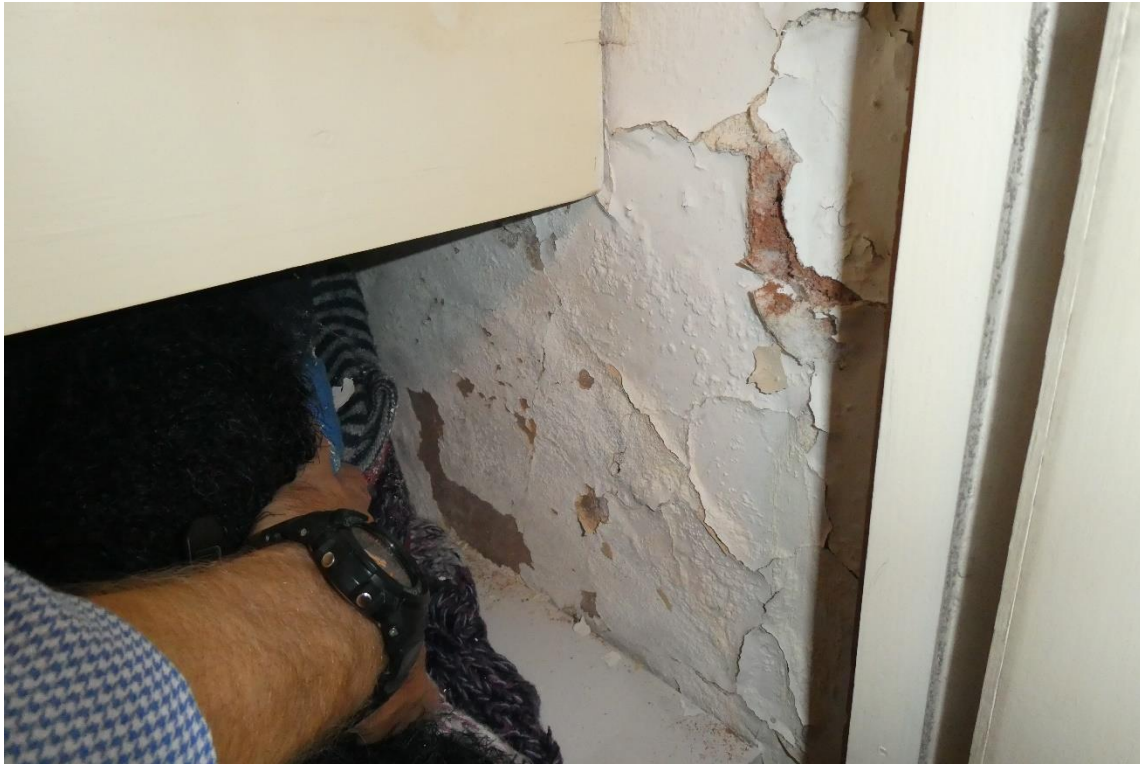
- Damp damage and very high readings to right-hand cupboard within ensuite entrance area. The vendor indicated that a repair has been carried out. Your solicitor should obtain the guarantee.

INSIDE OF THE CUPBOARD IS DAMP DAMAGED.

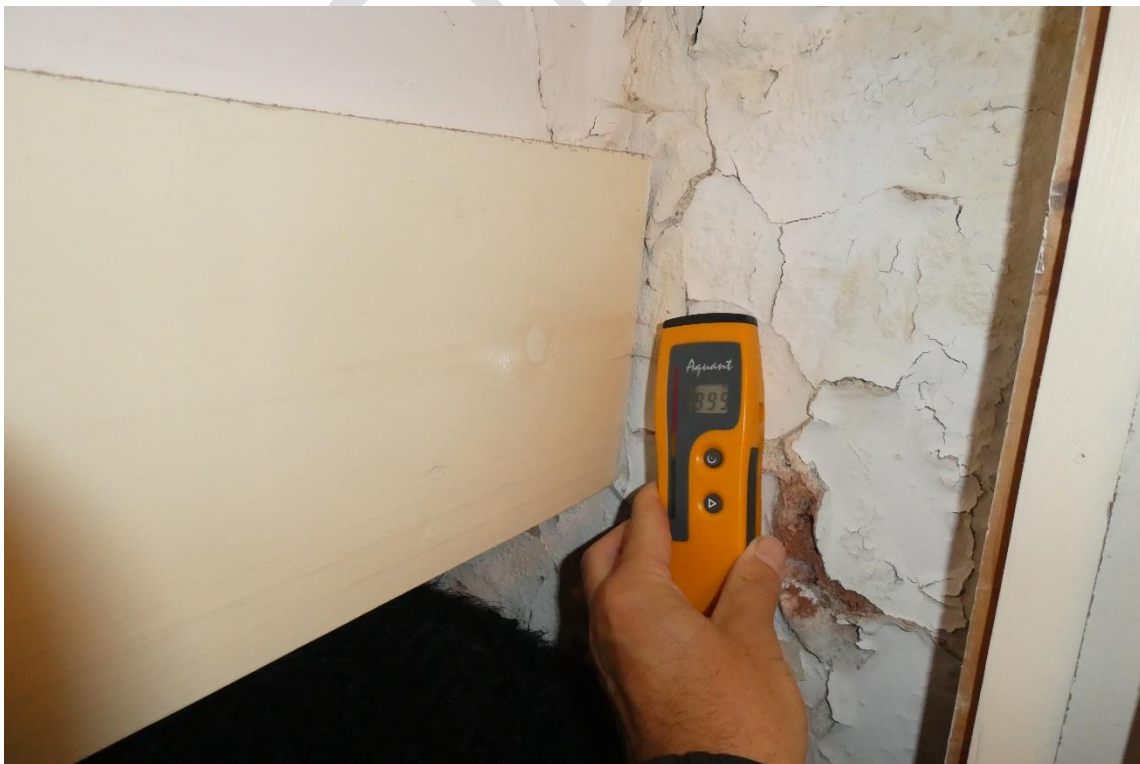
MAXIMUM METER READING.

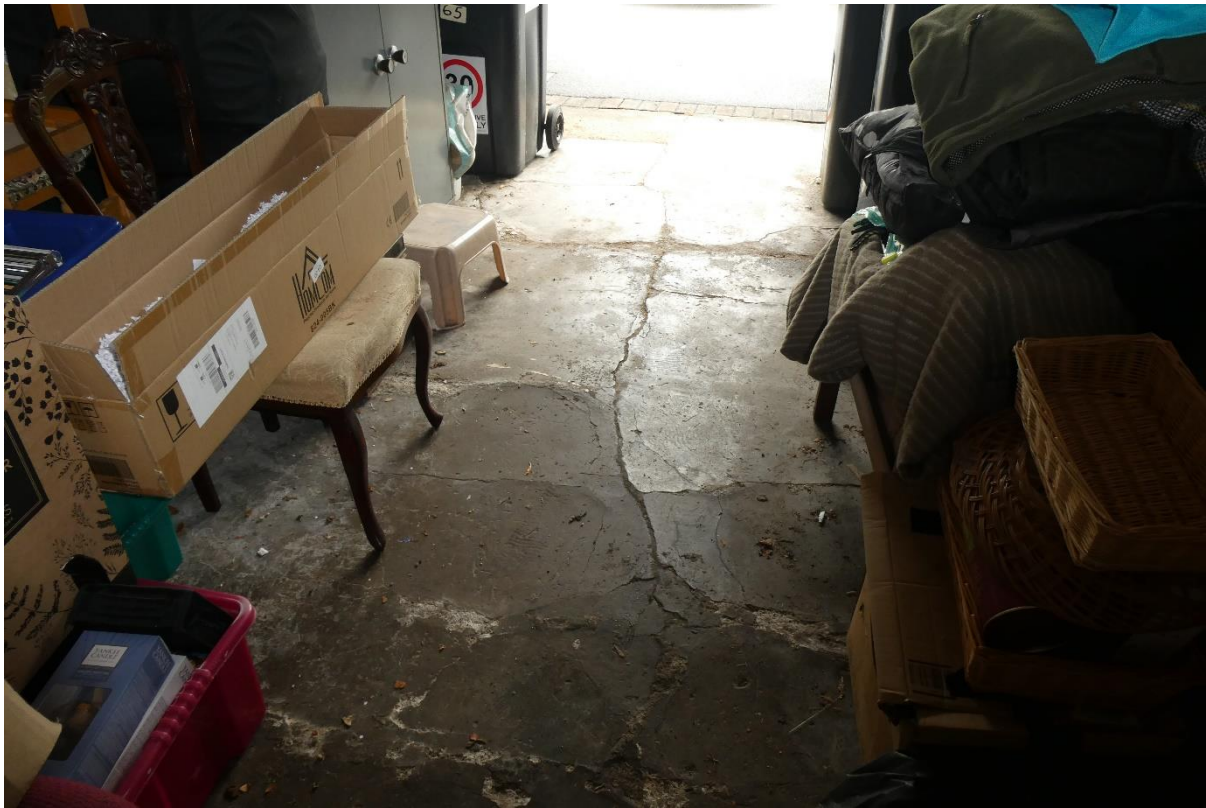
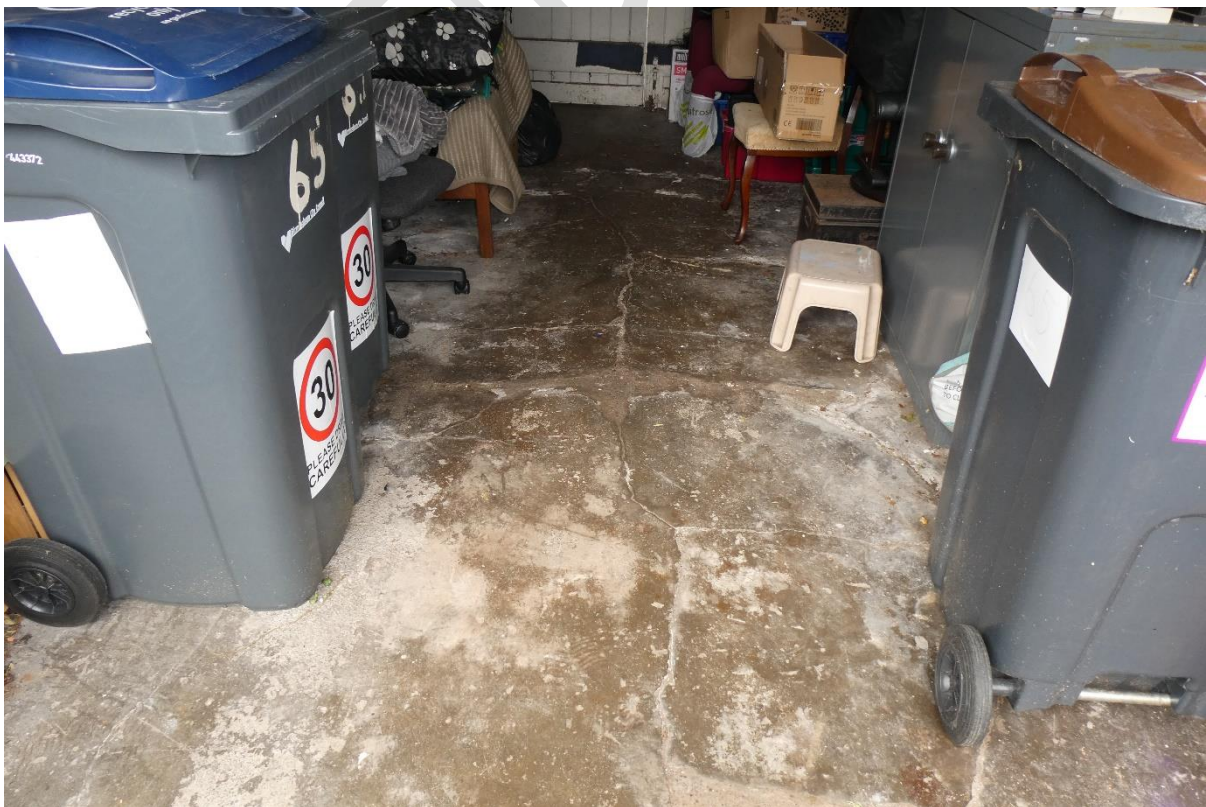
SULPHATE ATTACK.

**Action:** Replace garage floor slab.

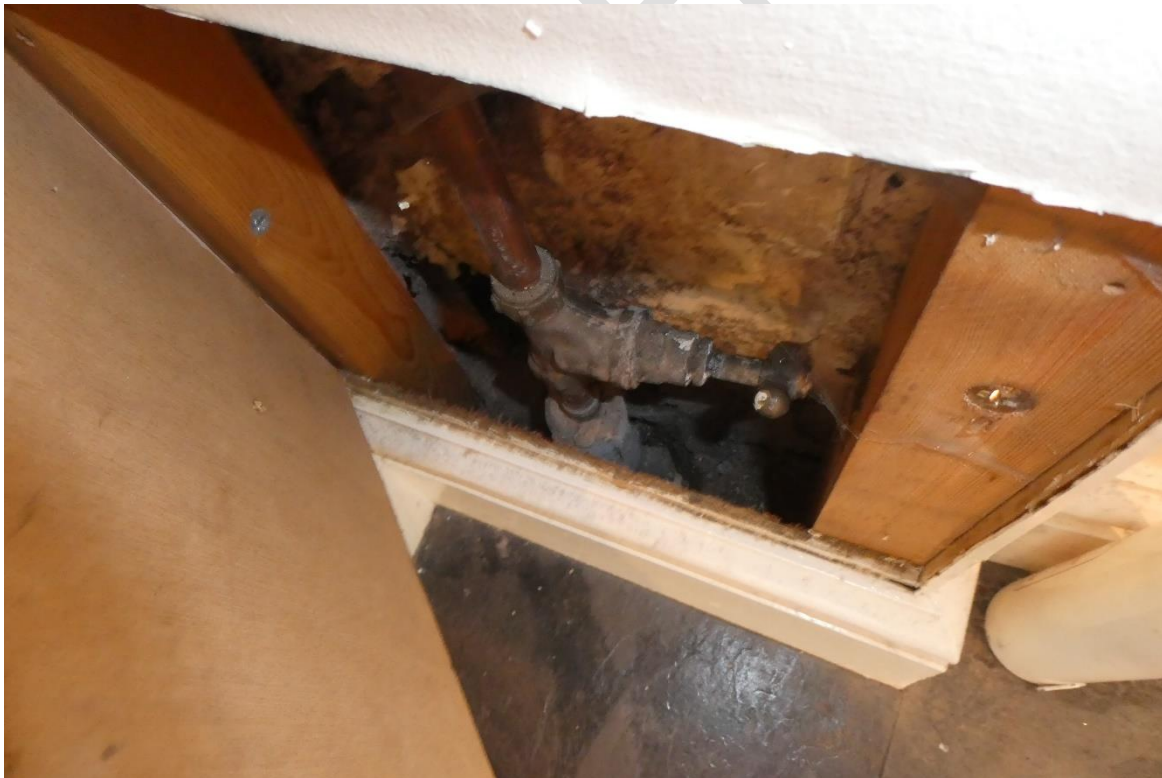
### LEAD WATER MAIN.

**Action:** Replace incoming water main (may be expensive); inspect central heating/gas and electrics; install mechanical extraction; CCTV survey drains.

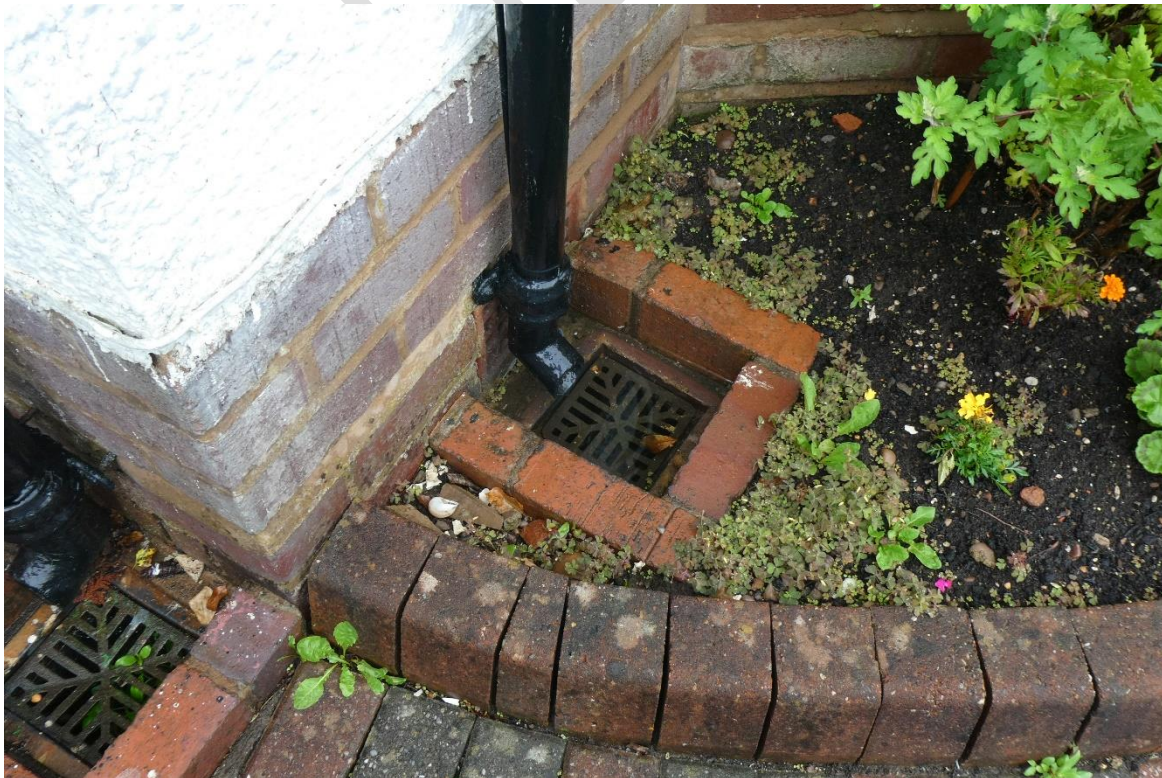
GULLEY FULL OF WATER.
