PRIVATE & CONFIDENTIAL REF: 0493/19

BUILDING SURVEY ON \*\*\*\*\*

Date of Survey: Two separate visits – \*\*\*\*\* and \*\*\*\*\*

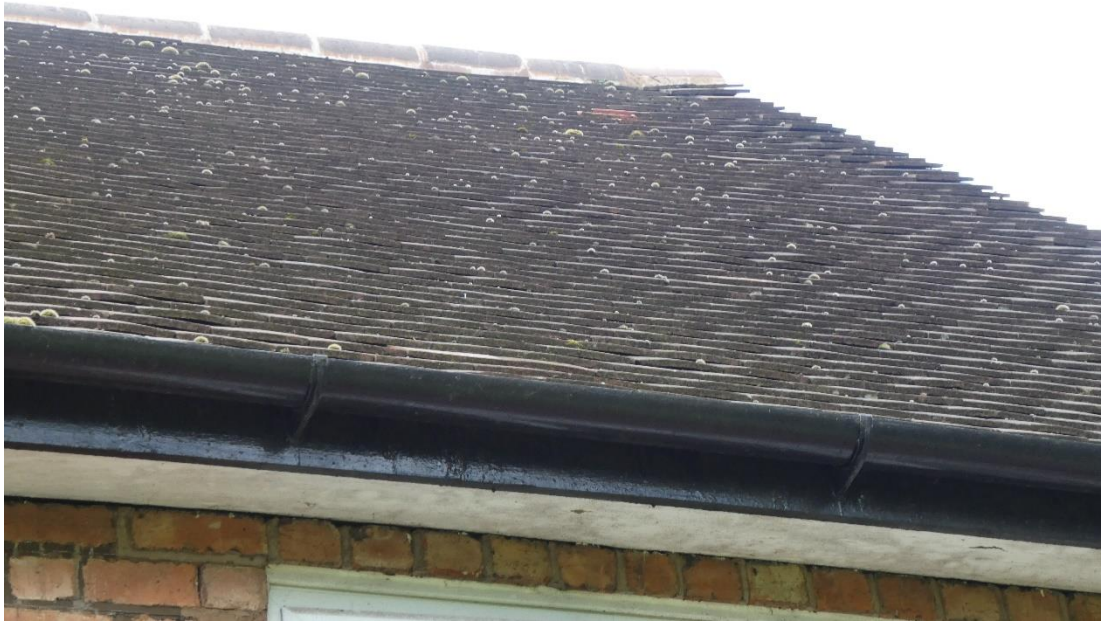
MOSS TO REAR ELEVATION.

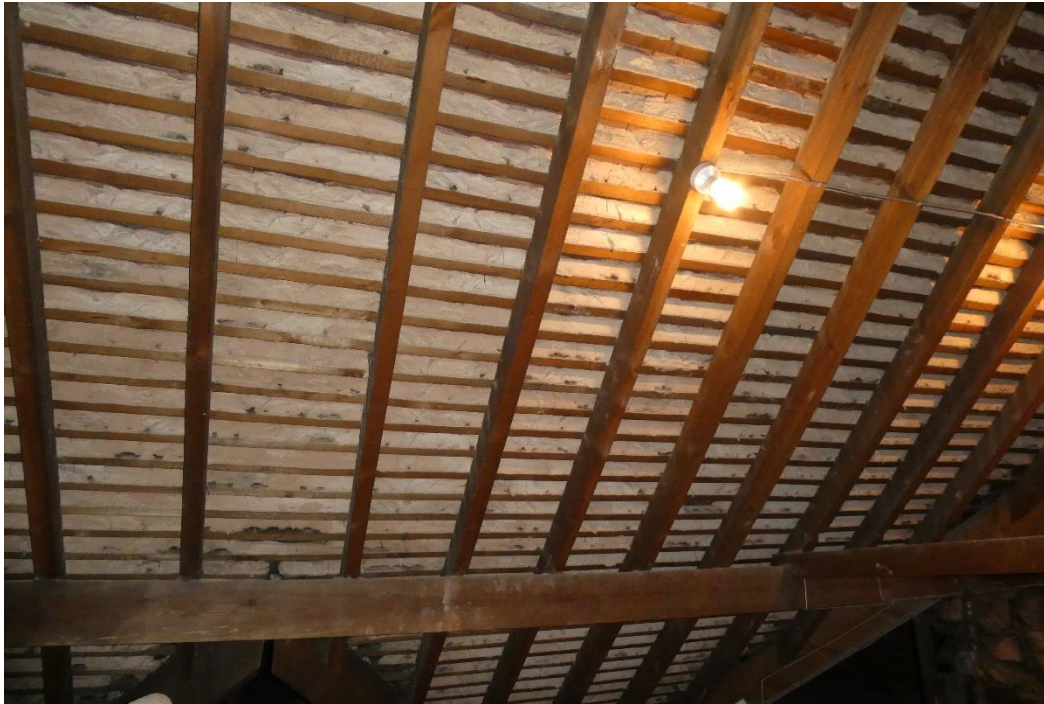
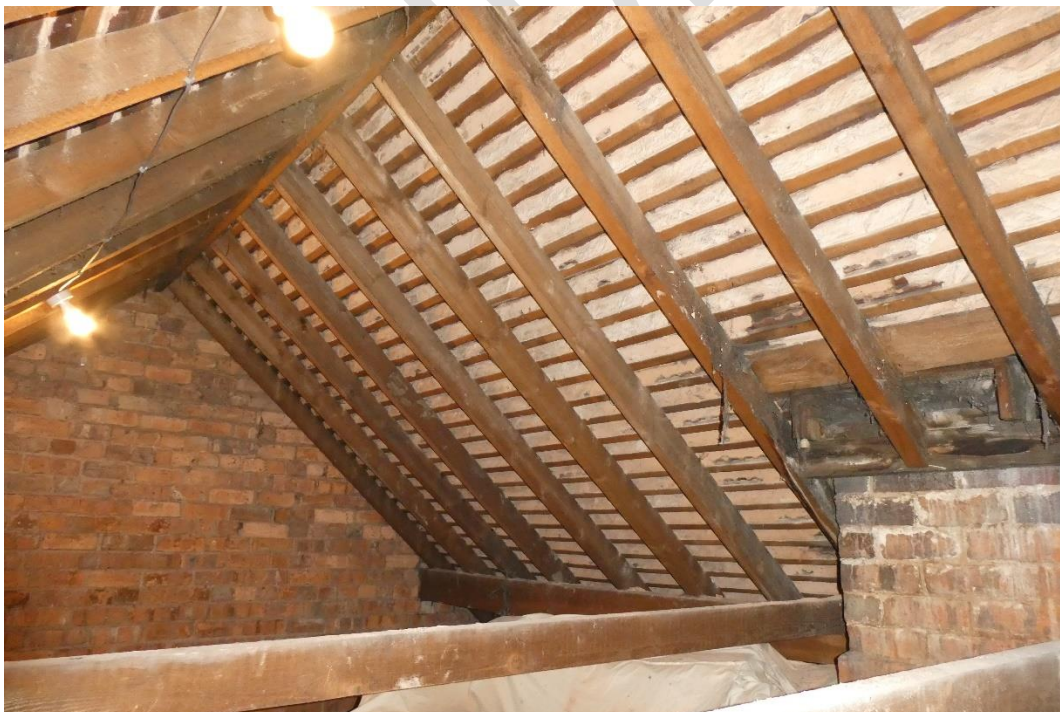
TORCHING IS STILL INTACT.

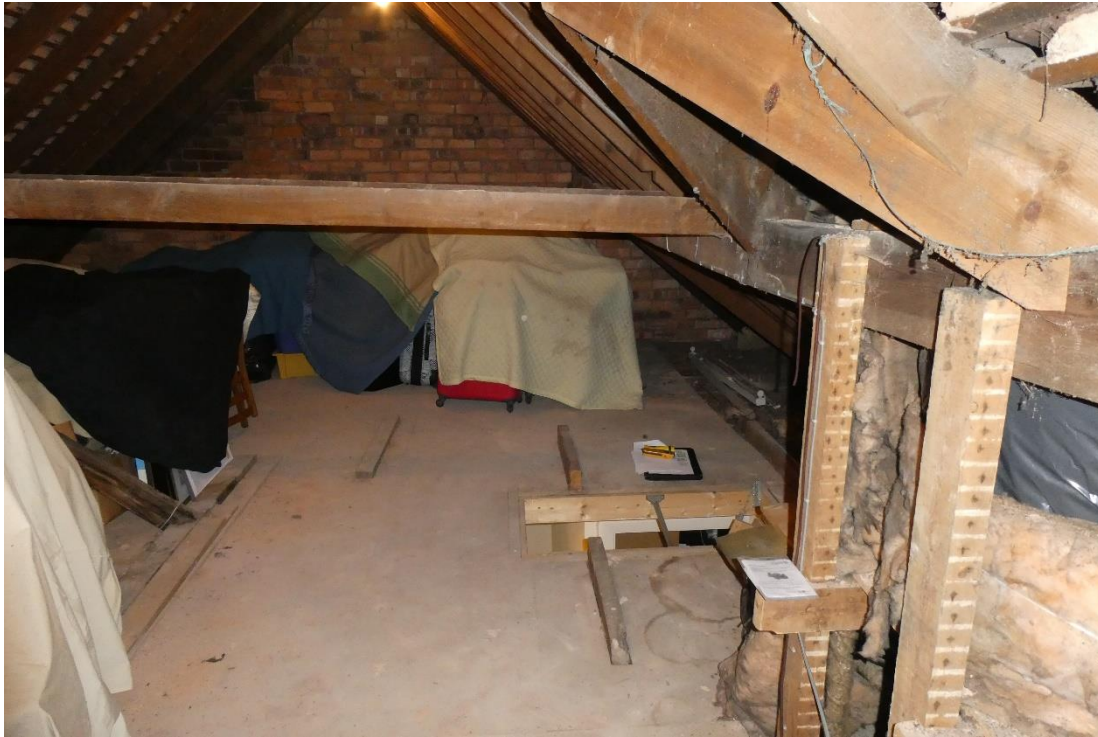
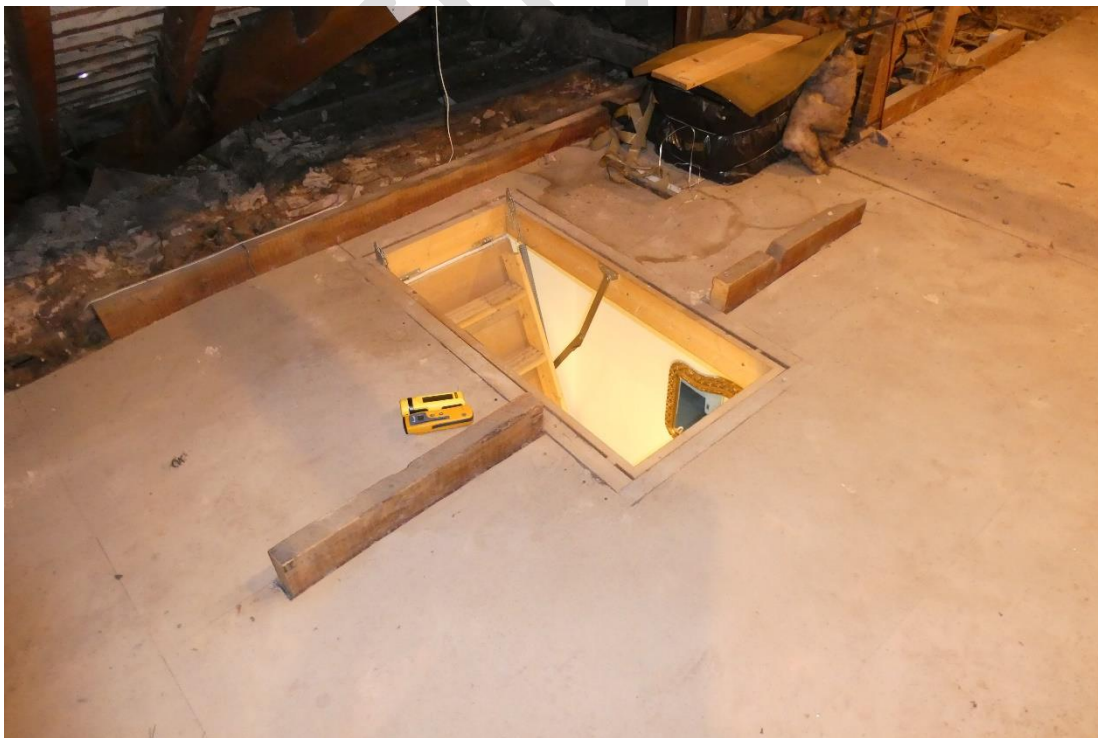
LOFT HATCH IS PLACED WHERE A DIAGONAL PROP HAS BEEN REMOVED.

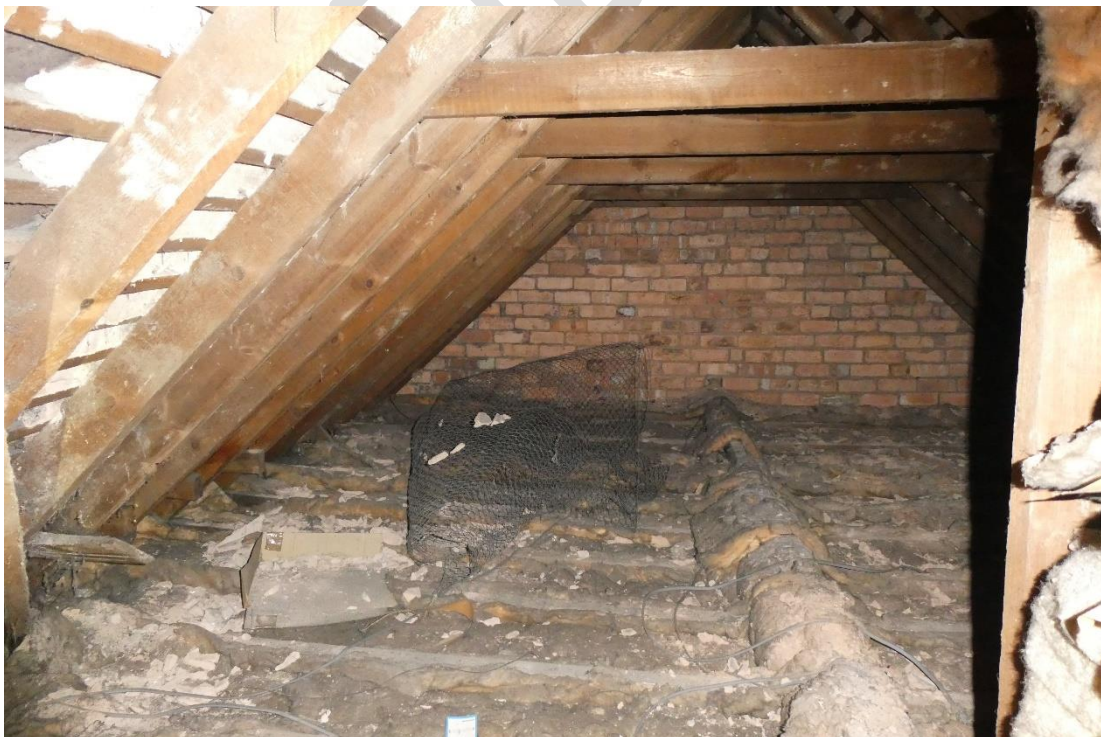
LOOKING INTO THE AREA ABOVE BEDROOM ONE.

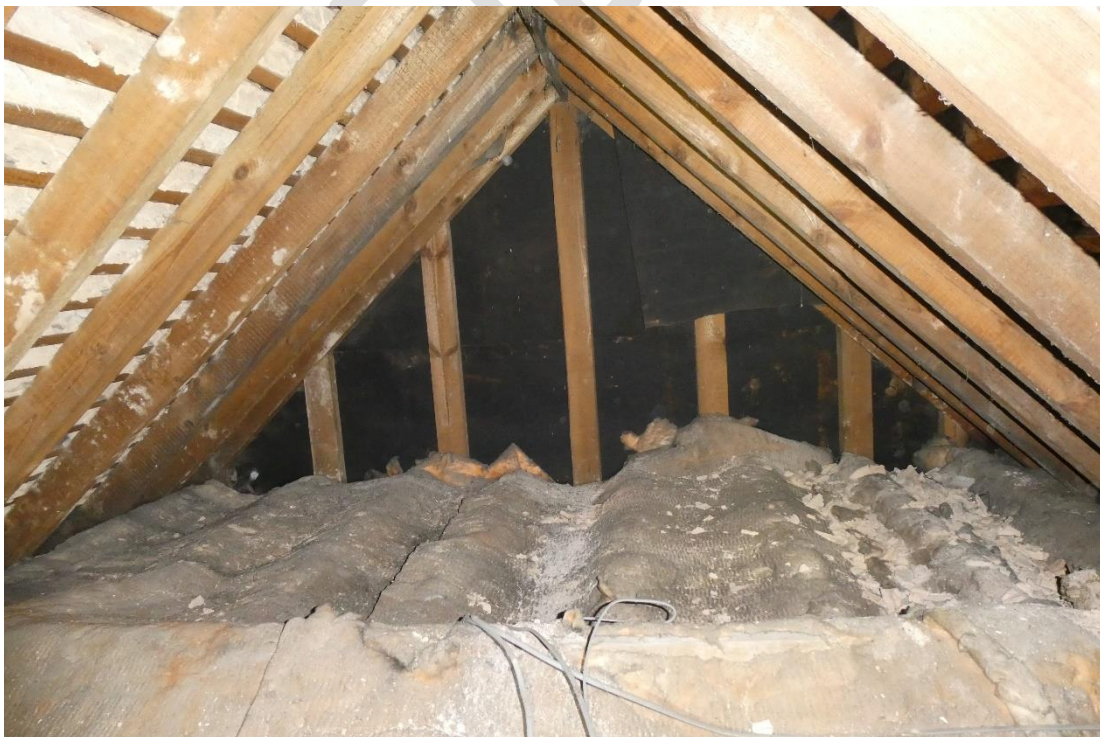
ABOVE BEDROOM FOUR. GABLE IS NOT BRICKWORK AND THEREFORE, DOES NOT NEED TO BE RESTRAINED.

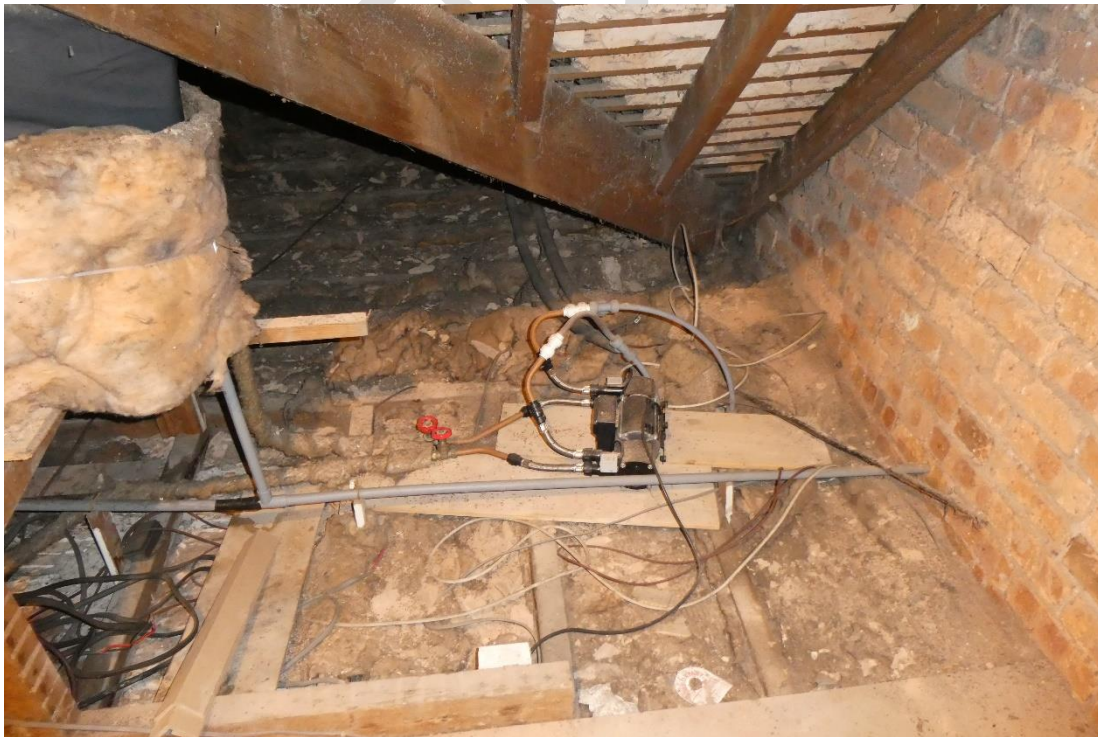
UNINSULATED WATER PIPES.

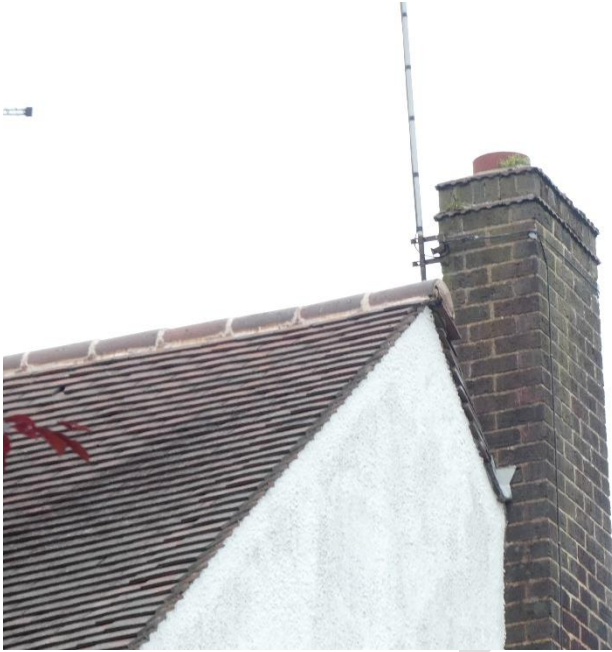
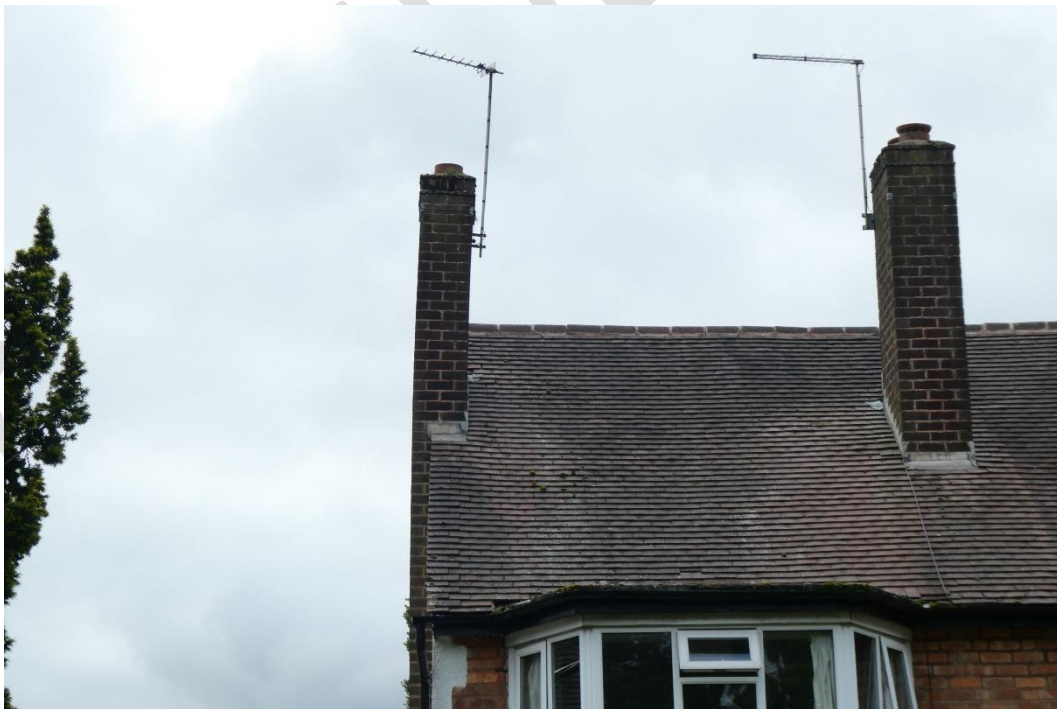
LEAN CAN BE SEEN ON RIGHT-HAND STACK.

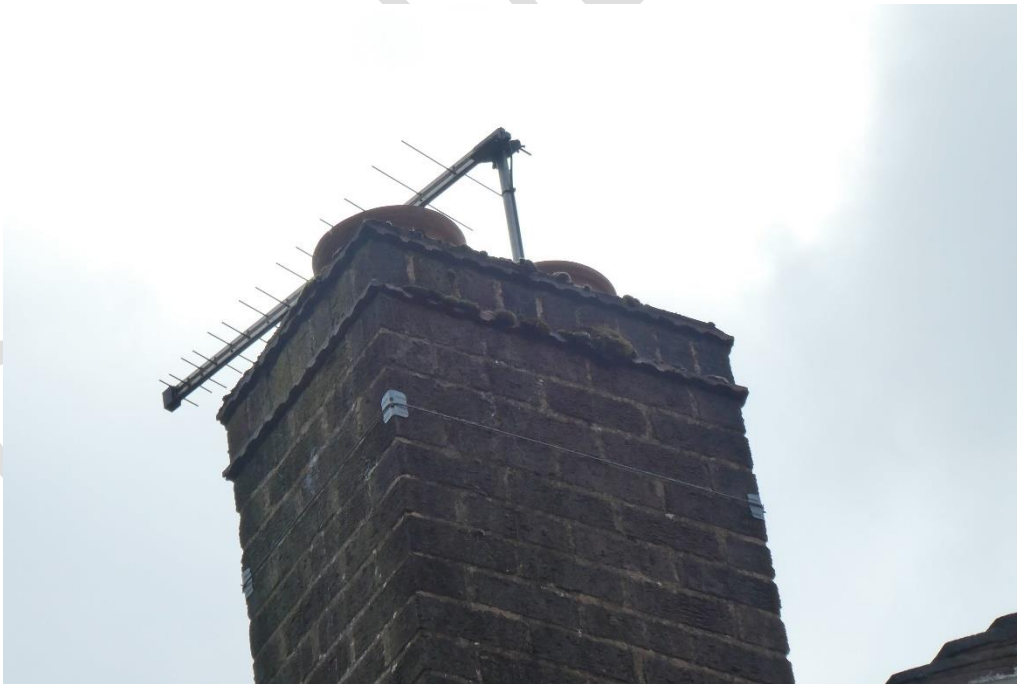
TOP OF REAR STACK IS DAMP.

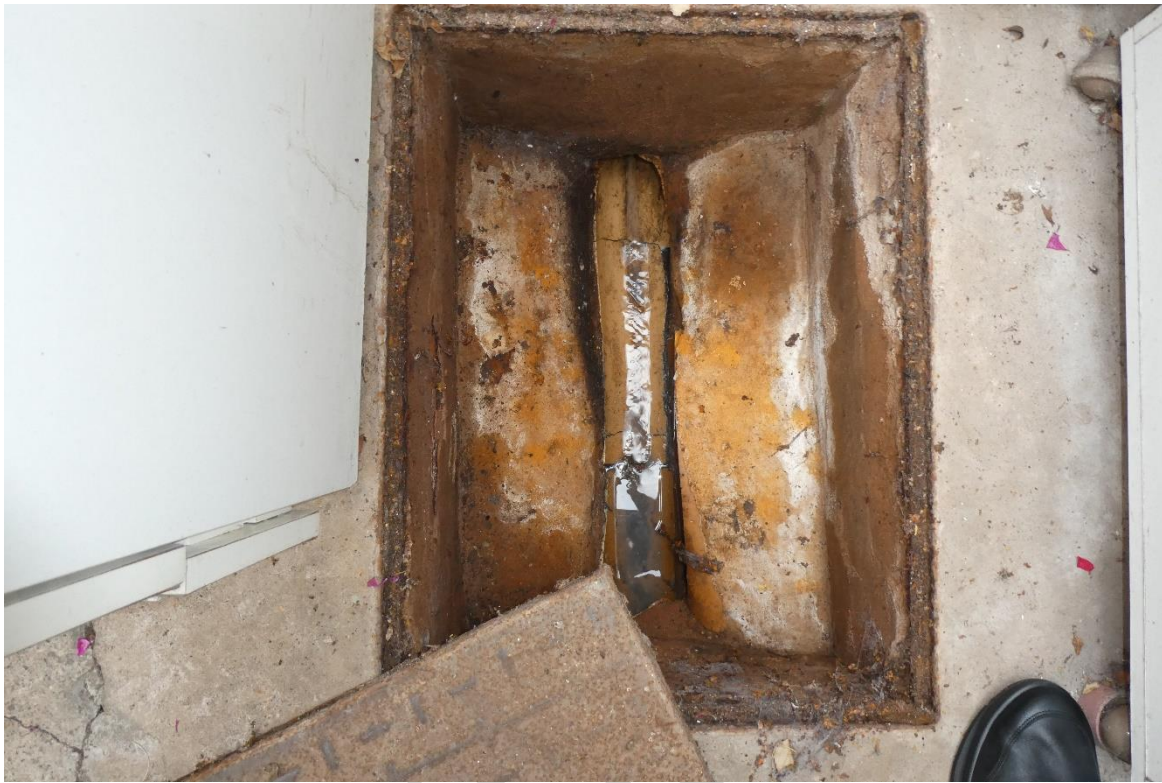
INSPECTION CHAMBER.
